PICUS SONIC TOMOGRAPH TEST (ST) SUMMARY REPORT.

COMPLETED FOR: MARIBYRNONG CITY COUNCIL

LOCATION: BUNBURY STREET, FOOTSCRAY

DATE: 20TH APRIL 2022

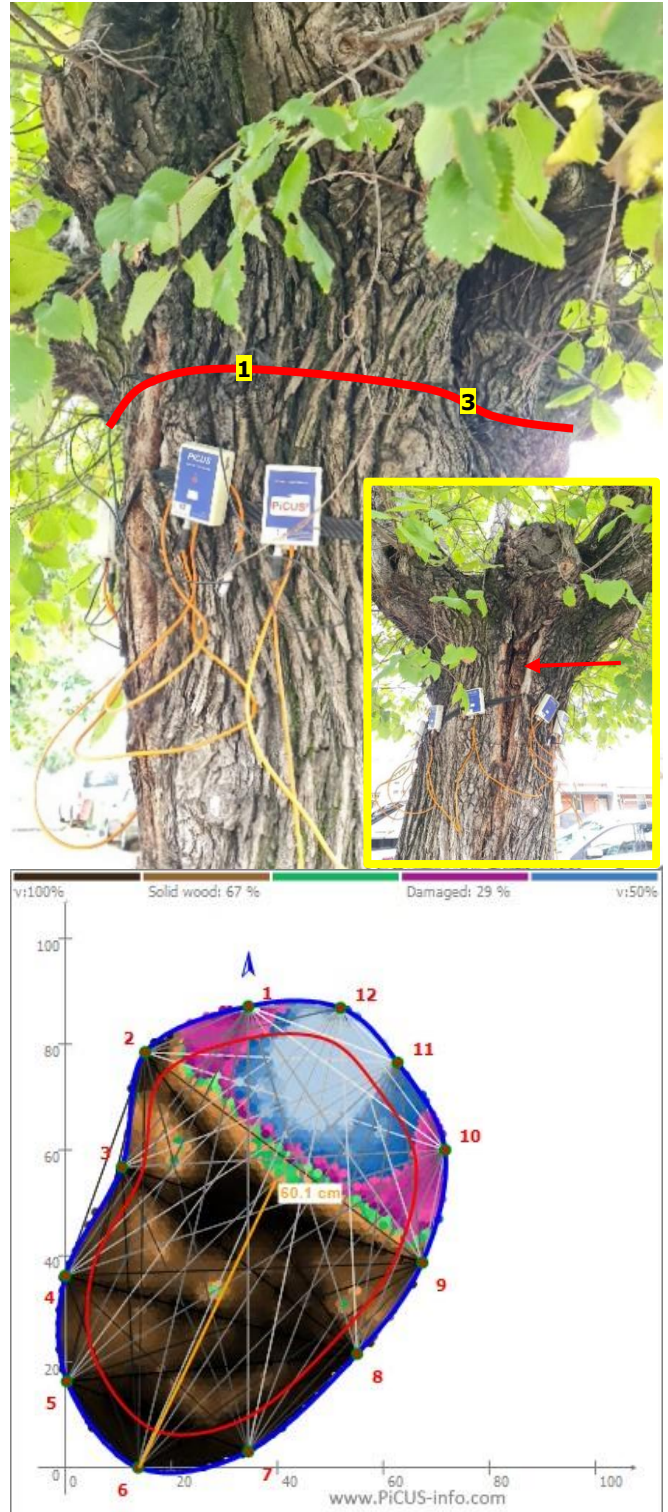
**Roadside reserve – 36 Bunbury Street
13**

The Sonic Tomograph test result indicates 67% of the test area is sound (high density) wood. There is 4% of incipient wood (wood being altered by the fungus). The remaining 29% is active fungus and decayed (low density) wood.

The tree has been pollarded in the past above the test height at approximately 2.5 metres above ground level. The primary unions of the pollard heads intersects with the outer trunk at sensors 3, 4-5, 8 and 11-12. Decay was observed in some of the old pruning wounds at the old pollarding points. It is likely that the decay causing pathogen has spread into the trunk from the old pollarding points resulting the incipient and dysfunctional wood shown in the test result. Additionally, a linear wound was observed between sensor 11 and sensor 12 (see red arrow in photograph in yellow box).

The test result shows that the incipient and dysfunctional wood is contained to the north-eastern sector of the test point and is impacting the northern and eastern pollard heads. The pathogen has caused significant degradation to the compression wood of the pollard heads but there is still sound structural wood providing support for the northern and eastern pollard heads. Also, the northern side of the canopy has limited lateral load because of routine service wires clearance pruning. Furthermore, the test result indicates that the tree is developing reactive zones to slow the progression of the fungus. This can be seen in the test result by the low percentage of incipient wood.

It is observed that new wood growth increments are occurring at sensors 2, 5, 6, 7 and 8.

The timeframe allowed before the tree is unsafe and removal is the only option will be determined by the rate of spread of the fungus.

The tree displays health and vigour that is typical for the species and the test result provides evidence that the tree is structurally sound at the test height.

The tree has an estimated life expectancy of greater approximately 20 years at the test point. It is recommended that the tree is retested in 3 years to assess the progression of the pathogen and to re-evaluate the structural integrity of the trunk at the test height. It is also recommended that routine pruning of the northern side of the canopy is undertaken to limit lateral load on the unions of the northern and eastern pollard heads.

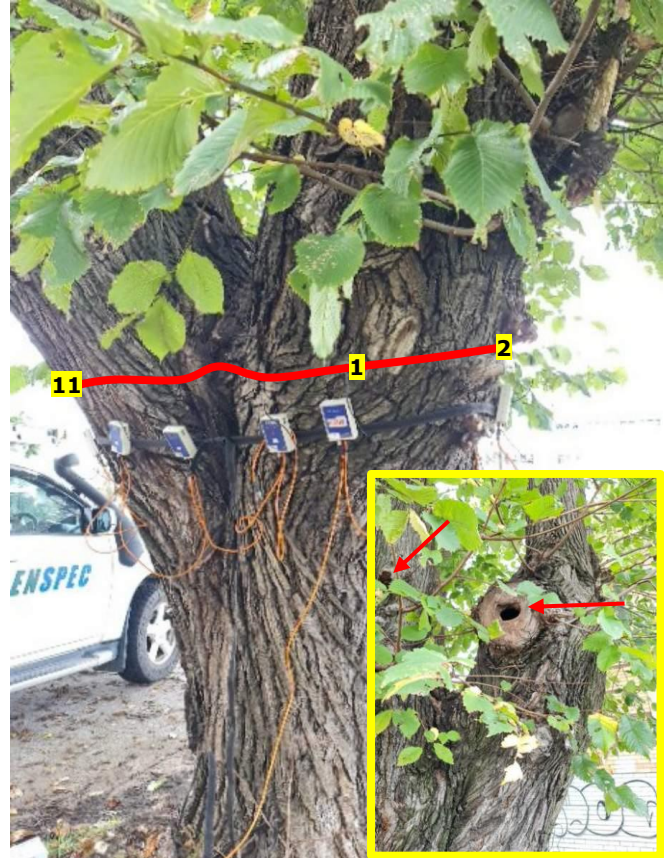
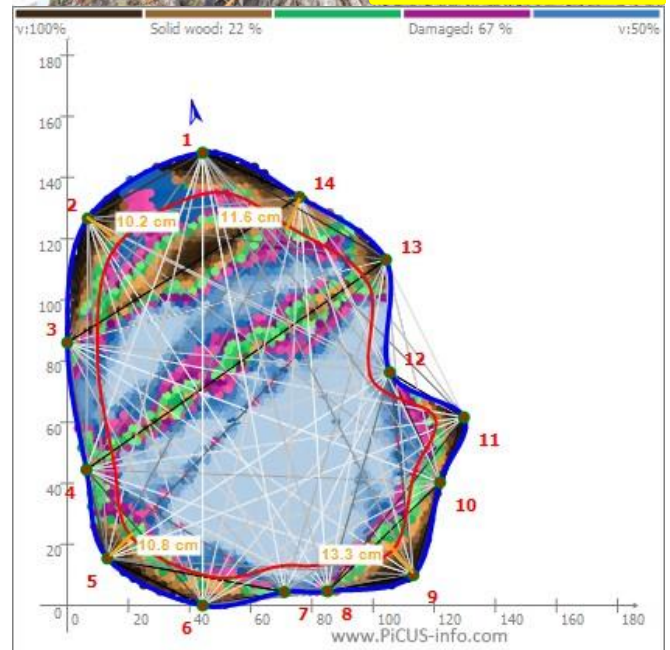
Roadside reserve – on Bunbury Street frontage at corner of Whitehall Street & Moreland Street 22

The Sonic Tomograph test result indicates 22% of the test area is sound (high density) wood. There is 11% of incipient wood (wood being altered by the fungus). The remaining 67% is active fungus and decayed (low density) wood.

The tree has been pollarded in the past above the test height at approximately 3 metres above ground level. Decay was observed in some of the old pruning wounds at the old pollarding points (see red arrows in photograph in yellow box). It is likely that the decay causing pathogen has spread into the trunk from the old pollarding points resulting in the incipient and dysfunctional wood shown in the test result.

The primary union of the pollard heads intersects with the outer trunk at sensors 4 and 12. The test result shows that the pathogen has caused significant degradation to the structural integrity of the primary union.

Additionally, the test result shows that the dysfunctional wood has encroached into the t/R ratio (set at 15%). The t/R ratio is only used as a guide to evaluate the sound wood/dysfunctional wood ratio and should not be used as an index of trunk failure potential. However, there is very limited structural wood, particularly on the western and eastern sides of the test point, with a very high percentage of the trunk area assessed as non-functional wood.

Although the test result shows new wood growth increments are occurring at sensors 1, 2, 5, 9, 11 and 13, the extent of the dysfunctional wood at the test height was assessed as a structural defect in the trunk.

The test result provides evidence that the structural integrity of the trunk at the test height has been substantially compromised by the spread of the pathogen from the old pollard heads pruning points.

The tree is recommended for removal because of its poor canopy management history and reduced life expectancy due to the extent of trunk decay.
