Risk Assessment and Recommended Works Report

Updated assessment of an avenue of trees along
Bunbury Street, between Hyde and Moreland Streets,
Footscray.

Wednesday 4th May 2022

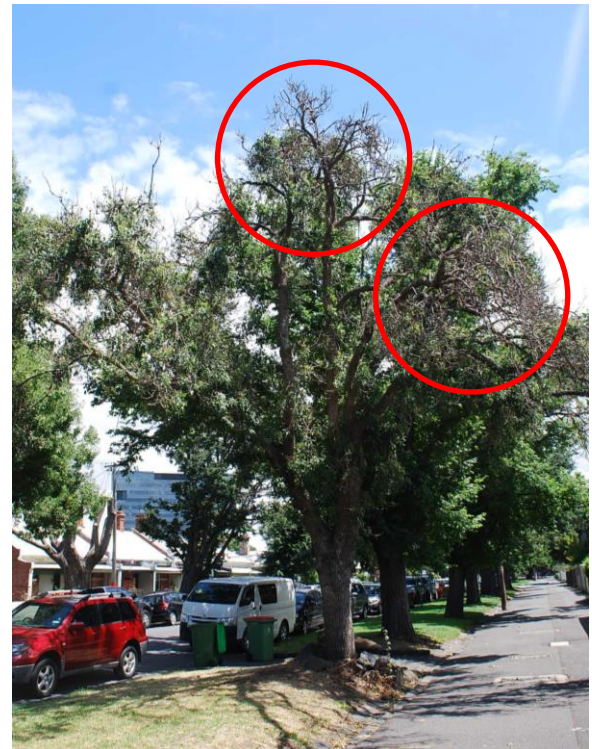
Figure 6: Tree 16 in 2022. Major dieback of limbs

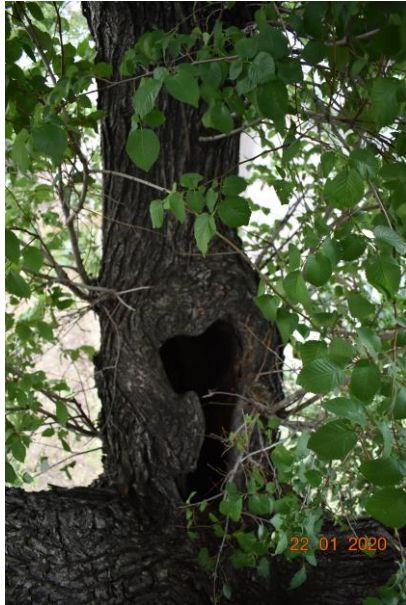
Figure 12: Tree 36 with large cavity at union to main stem, increasing risk of failure for major branch.

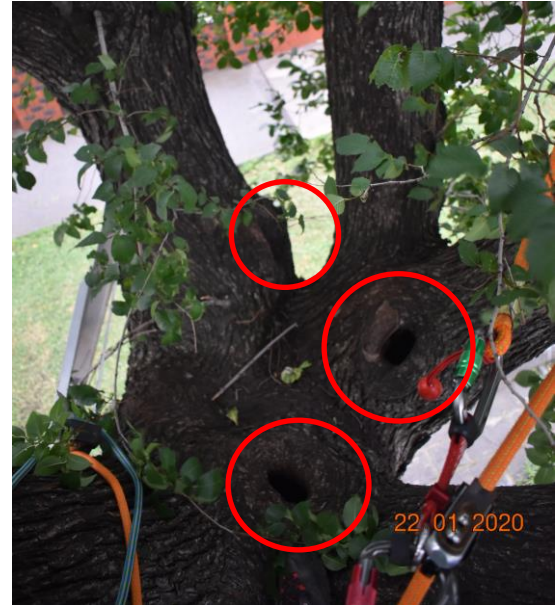
Figure 13: Multiple cavities located at unions of main branches, compromising overall structural integrity of Tree 30

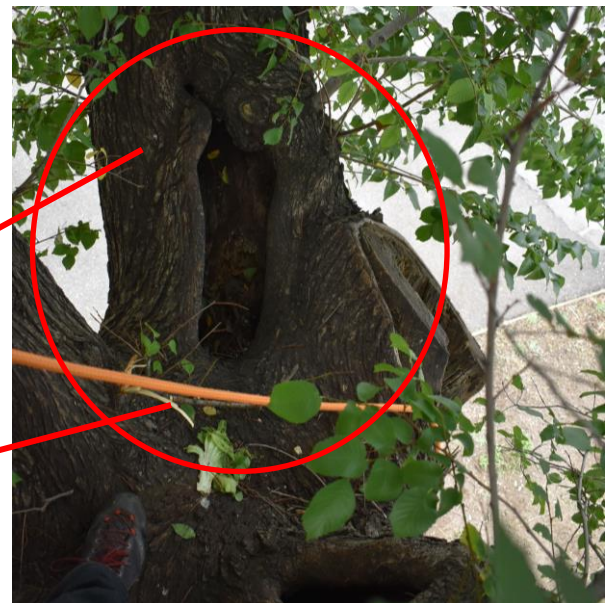
Figure 15: Heavy decay located at major union with large open cavities present.

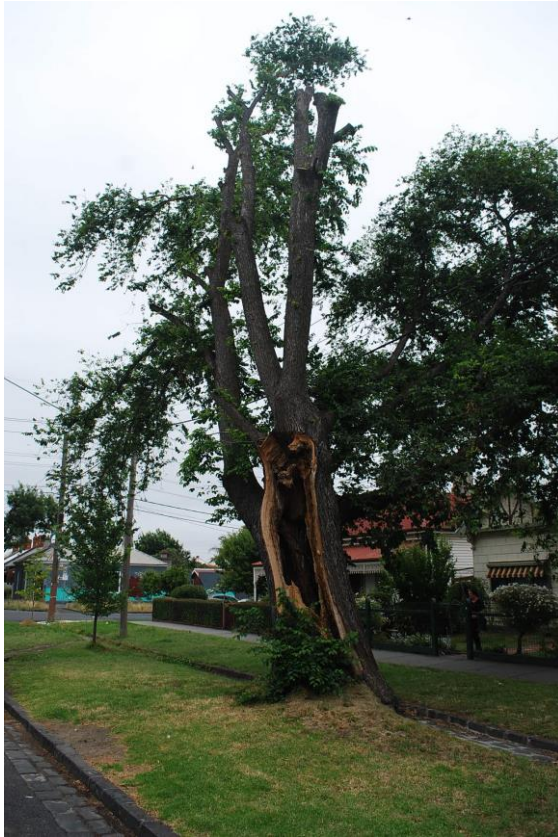
Two trees have had major failures since the previous assessments in 2020. Tree 33 has since been removed and Tree 47 is still within the landscape (Figure 16 Figure 17). Both of these trees were recommended for removal at the December 2021 site visit. Tree 47 still poses a risk of branch failure over the footpath and this tree should be removed as soon as possible.

Figure 16: Pruning has been carried out to reduce risk on the roadside of Tree 47.

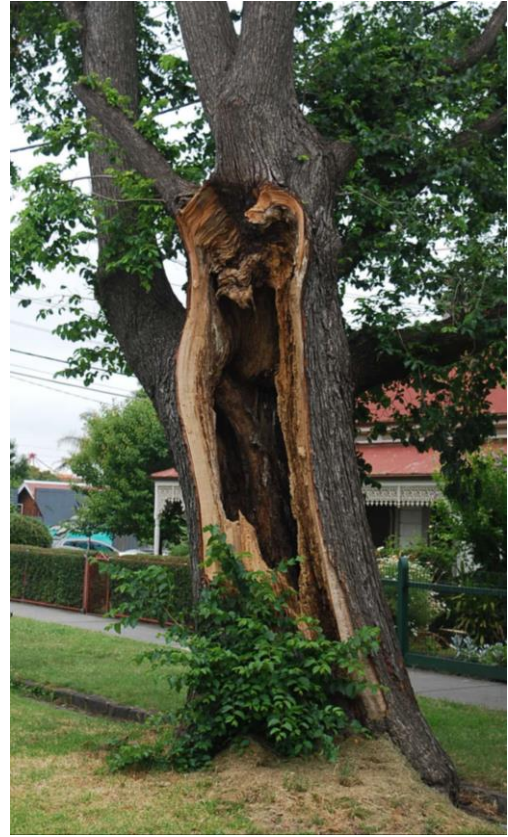
Figure 17: Close up of hollow trunk and large stem failure.

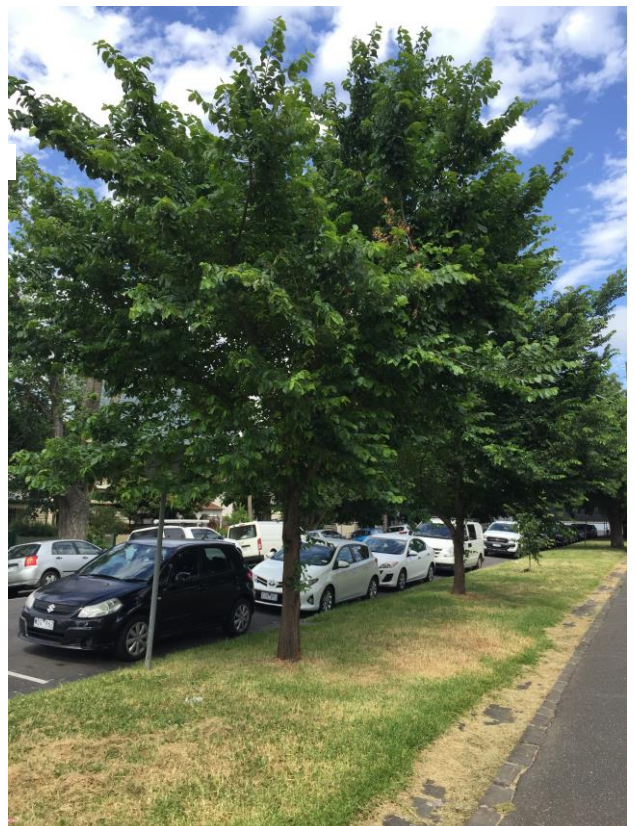
Tree Number: 9**Botanical Name:** *Ulmus procera***Common Name:** English Elm**Assessment Level:** Level 2**Height & Width (m):** 7 x 8**DBH (cm):** 30**Health:** Good**Structure:** Fair**ULE:** 40+ years**Maturity:** Semi mature**Recommended Works:** No works**Priority:** None**Failure Potential:** 3. Moderate**Failure Size:** 4. 26-100mm**Target Occupancy:** 2. Pedestrians, 8-72/hr**Risk of Harm** **1 in 500,000****Risk Category:** Moderate**Comments:** Borers

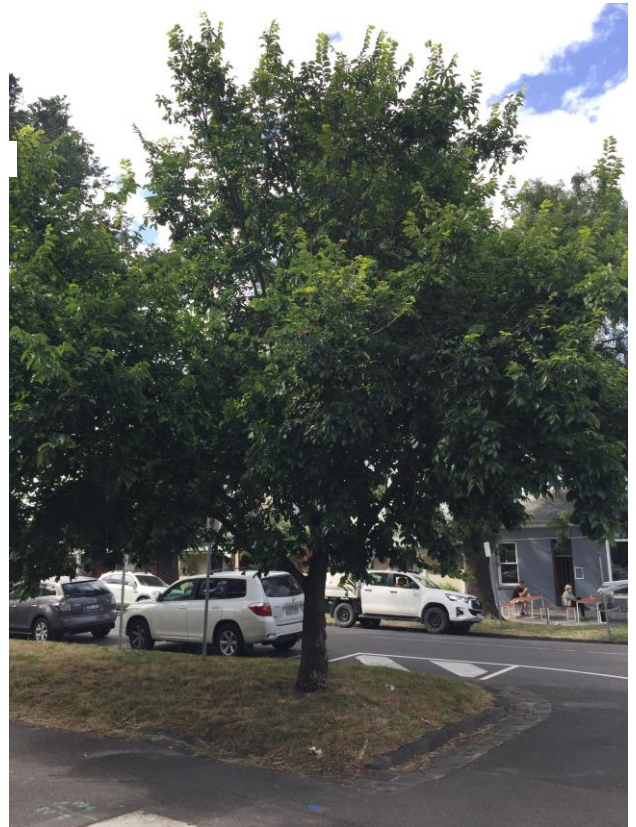
**Tree Number: 10****Botanical Name:** *Ulmus procera***Common Name:** English Elm**Assessment Level:** Level 3 - Aerial Inspection, Tomograph**Height & Width (m):** 12 x 10**DBH (cm):** 103**Health:** Poor**Structure:** Fair**ULE:** 0 years**Maturity:** Mature**Recommended Works:** Removal**Priority:** High**Failure Potential:** 2. High**Failure Size:** 3. 101-250mm**Target Occupancy:** 2. Pedestrians, 8-72/hr**Risk of Harm** **1 in 5,000****Risk Category:** High**Comments:** Tomograph results show a compromised trunk with heavy decay at the test site

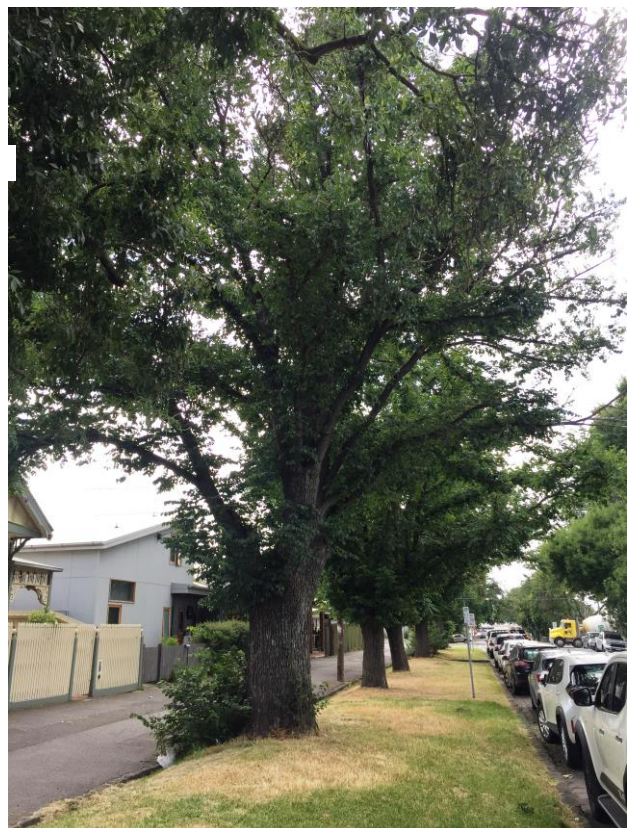
Tree Number:	13
Botanical Name:	<i>Ulmus procera</i>
Common Name:	English Elm
Assessment Level:	Level 3 - Aerial Inspection, Tomograph
Height & Width (m):	10 x 7
DBH (cm):	61
Health:	Poor
Structure:	Fair
ULE:	10 to 20 years
Maturity:	Mature
Recommended Works:	No works
Priority:	None
Failure Potential:	3. Moderate
Failure Size:	3. 101-250mm
Target Occupancy:	2. Pedestrians, 8-72/hr
Risk of Harm	1 in 50,000
Risk Category:	Moderate
Comments:	Dieback, deadwood. Tomograph results show structurally sound at the test site

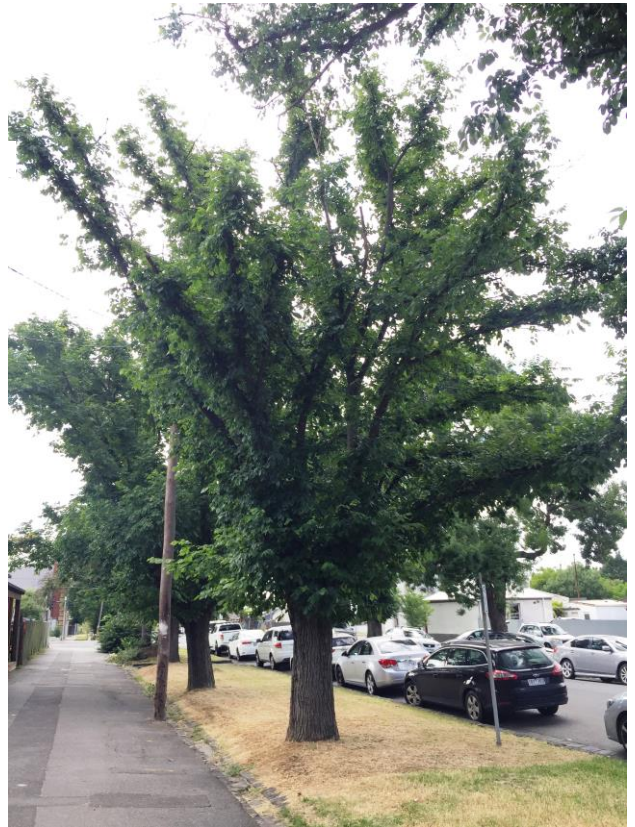
Tree Number:	14
Botanical Name:	<i>Ulmus procera</i>
Common Name:	English Elm
Assessment Level:	Level 3 - Aerial Inspection, Tomograph
Height & Width (m):	12 x 7
DBH (cm):	61
Health:	Poor
Structure:	Poor
ULE:	0 years
Maturity:	Mature
Recommended Works:	Removal
Priority:	High
Failure Potential:	2. High
Failure Size:	3. 101-250mm
Target Occupancy:	2. Pedestrians, 8-72/hr
Risk of Harm	1 in 5,000
Risk Category:	High
Comments:	Tomograph results show a compromised trunk with heavy decay at the test site

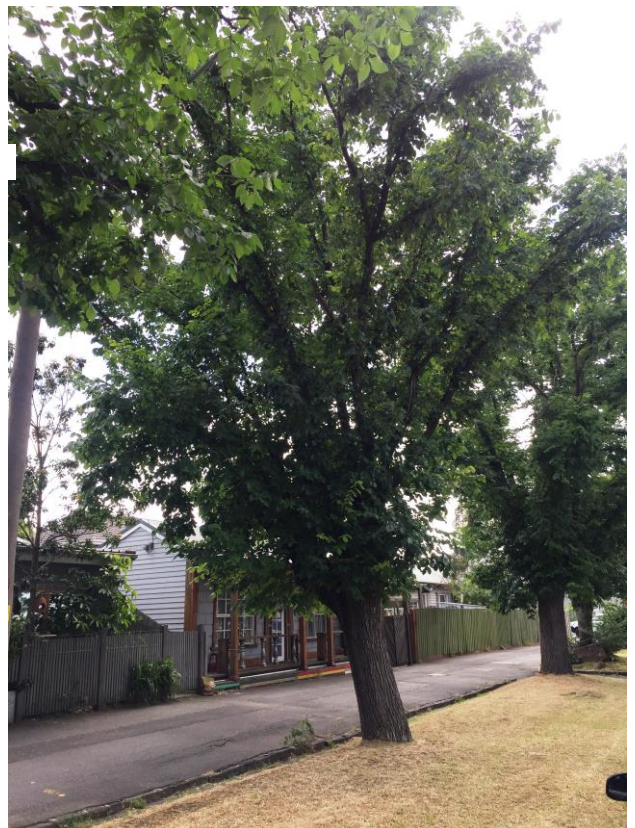
Tree Number:	15
Botanical Name:	<i>Ulmus procera</i>
Common Name:	English Elm
Assessment Level:	Level 3 - Aerial Inspection, Tomograph
Height & Width (m):	12 x 10
DBH (cm):	70
Health:	Fair
Structure:	Fair
ULE:	10 to 20 years
Maturity:	Mature
Recommended Works:	15-20% risk reduction pruning required of extended branches
Priority:	High
Failure Potential:	2. High
Failure Size:	3. 101-250mm
Target Occupancy:	2. Pedestrians, 8-72/hr
Risk of Harm	1 in 5,000
Risk Category:	High
Comments:	Tomograph results show very good condition at the test site. Bees nest towards path, dieback, deadwood

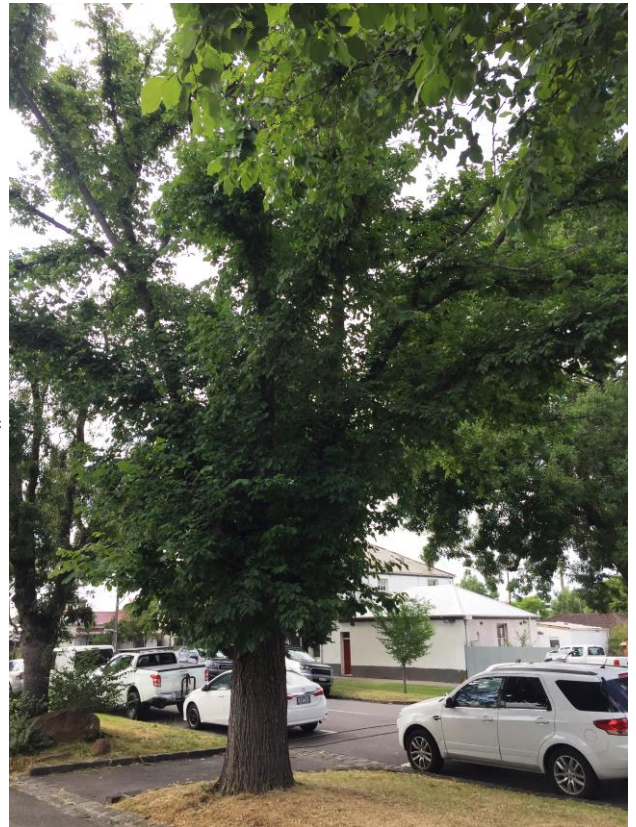
Tree Number:	16
Botanical Name:	<i>Fraxinus angustifolia subsp. angustifolia</i>
Common Name:	Desert Ash
Assessment Level:	Level 2
Height & Width (m):	10 x 9
DBH (cm):	49
Health:	Poor
Structure:	Fair
ULE:	Less than 5 years
Maturity:	Mature
Recommended Works:	Removal
Priority:	Moderate
Failure Potential:	2. High
Failure Size:	3. 101-250mm
Target Occupancy:	2. Pedestrians, 8-72/hr
Risk of Harm	1 in 5,000
Risk Category:	High
Comments:	Major dieback, declined since last assessment 2 years ago

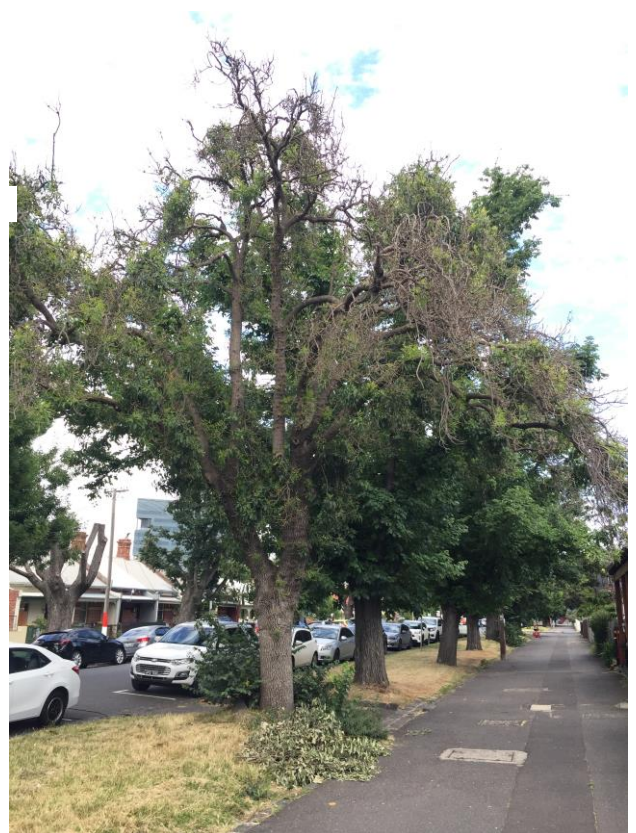
Tree Number: 17**Botanical Name:** *Ulmus procera***Common Name:** English Elm**Assessment Level:** Level 2**Height & Width (m):** 9 x 6**DBH (cm):** 115**Health:** Poor**Structure:** Poor**ULE:** 5 to 10 years**Maturity:** Mature**Recommended Works:** Removal**Priority:** High**Failure Potential:** 4. Low**Failure Size:** 4. 26-100mm**Target Occupancy:** 2. Pedestrians, 8-72/hr**Risk of Harm** **1 in 5,000,000****Risk Category:** Low**Comments:** Previous large failures, lopped at trunk, epicormic growth. ULE extended due to being lopped and risk reduced

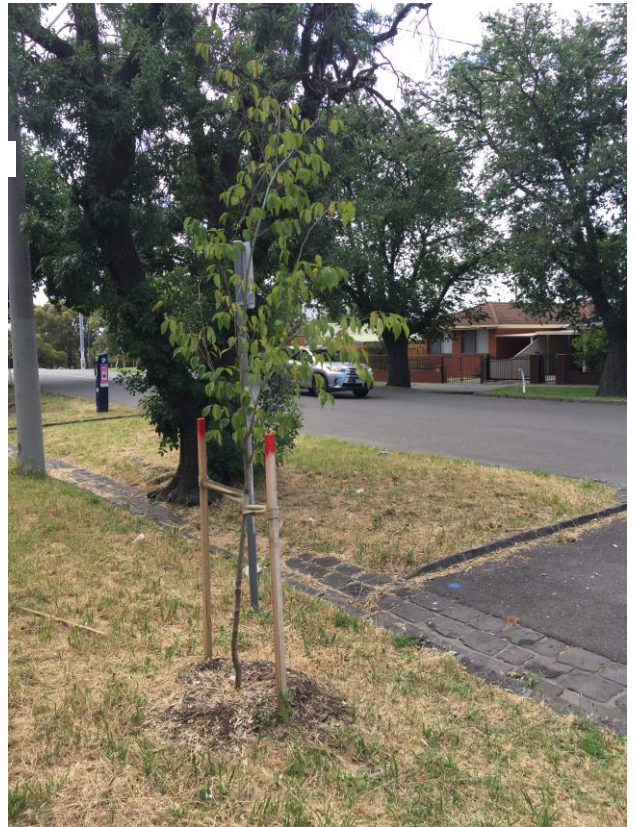
Tree Number: 22
Botanical Name: *Ulmus procera*
Common Name: English Elm
Assessment Level: Level 2
Height & Width (m): 15 x 13
DBH (cm): 104
Health: Good
Structure: Poor
ULE: Less than 5 years
Maturity: Mature
Recommended Works: Removal
Priority: High
Failure Potential: 2. High
Failure Size: 3. 101-250mm
Target Occupancy: 2. Pedestrians, 8-72/hr
Risk of Harm **1 in 5,000**
Risk Category: High
Comments: Tomograph results show a compromised trunk with heavy decay at the test site

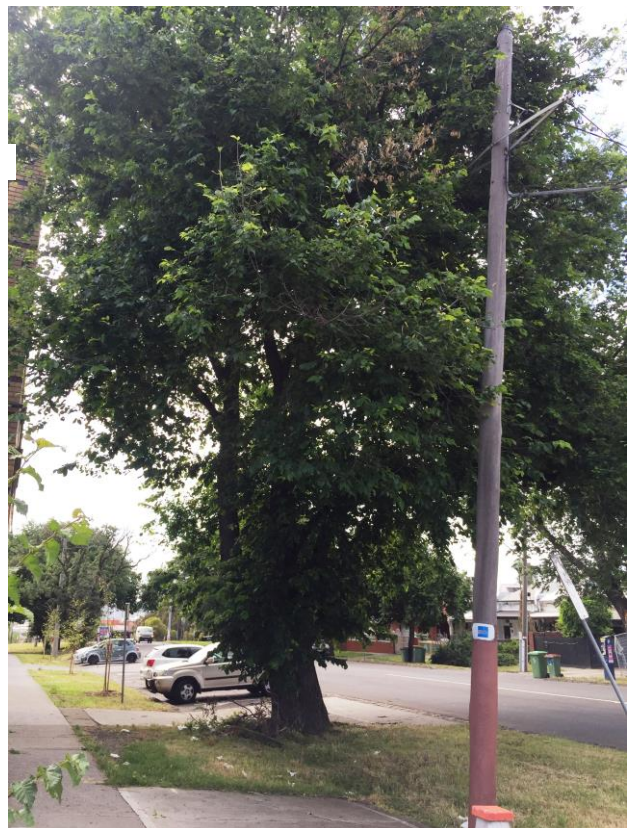
Tree Number: 23**Botanical Name:** *Fraxinus angustifolia subsp. angustifolia***Common Name:** Desert Ash**Assessment Level:** Level 2**Height & Width (m):** 10 x 8**DBH (cm):** 84**Health:** Poor**Structure:** Fair**ULE:** Less than 5 years**Maturity:** Mature**Recommended Works:** Removal**Priority:** Moderate**Failure Potential:** 3. Moderate**Failure Size:** 3. 101-250mm**Target Occupancy:** 2. Pedestrians, 8-72/hr**Risk of Harm** **1 in 50,000****Risk Category:** Moderate**Comments:** Major dieback and deadwood

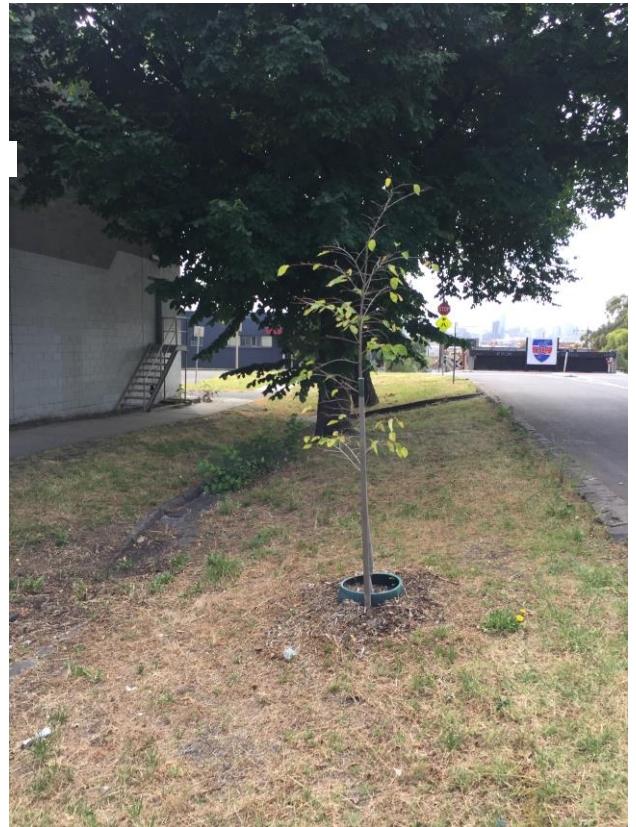
**Tree Number:** 26**Botanical Name:** *Ulmus procera***Common Name:** English Elm**Assessment Level:** Level 3 - Tomograph**Height & Width (m):** 11 x 10**DBH (cm):** 55**Health:** Good**Structure:** Fair**ULE:** 20 to 40 years**Maturity:** Mature**Recommended Works:** No works**Priority:** None**Failure Potential:** 3. Moderate**Failure Size:** 4. 26-100mm**Target Occupancy:** 2. Pedestrians, 8-72/hr**Risk of Harm** **1 in 500,000****Risk Category:** Moderate**Comments:** Tomograph results show good condition at the test site. Bees nest

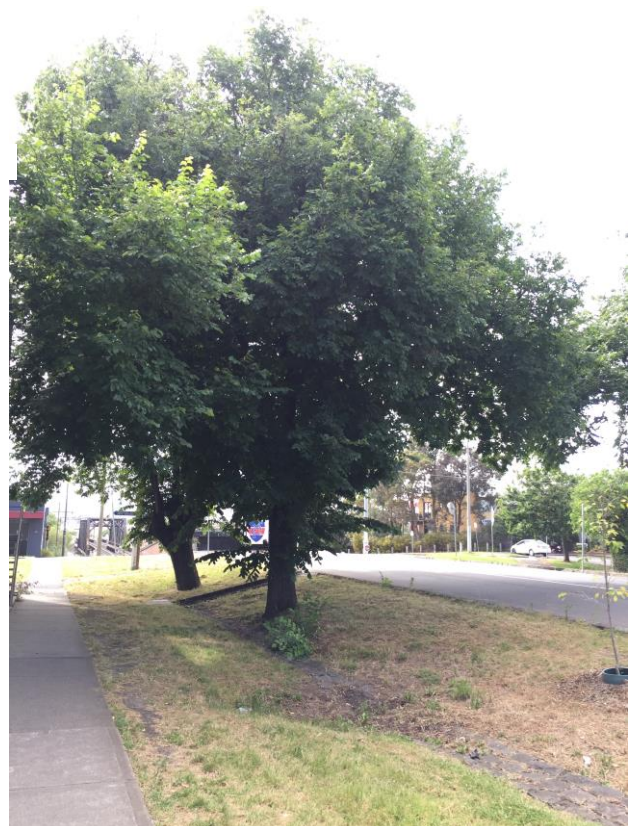
Tree Number: 27**Botanical Name:** *Ulmus procera***Common Name:** English Elm**Assessment Level:** Level 3 - Tomograph**Height & Width (m):** 11 x 10**DBH (cm):** 77**Health:** Fair**Structure:** Fair**ULE:** 0 years**Maturity:** Mature**Recommended Works:** Removal**Priority:** High**Failure Potential:** 2. High**Failure Size:** 2. 251-450mm**Target Occupancy:** 2. Pedestrians, 8-72/hr**Risk of Harm** **1 in 1,000****Risk Category:** Very high

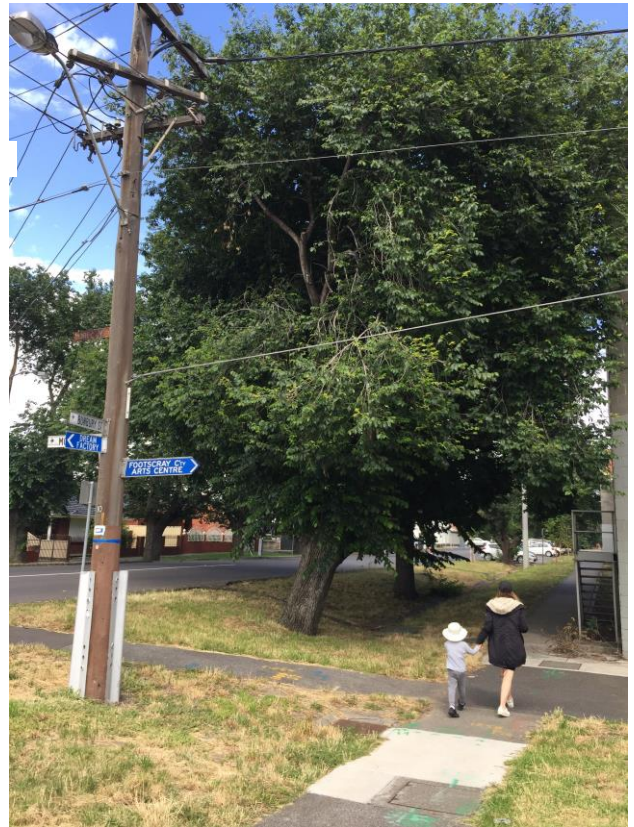
**Tree Number:** 28**Botanical Name:** *Ulmus procera***Common Name:** English Elm**Assessment Level:** Level 2**Height & Width (m):** 12 x 15**DBH (cm):** 79**Health:** Fair**Structure:** Poor**ULE:** Less than 5 years**Maturity:** Mature**Recommended Works:** Removal**Priority:** High**Failure Potential:** 2. High**Failure Size:** 2. 251-450mm**Target Occupancy:** 2. Pedestrians, 8-72/hr**Risk of Harm** **1 in 1,000****Risk Category:** Very high

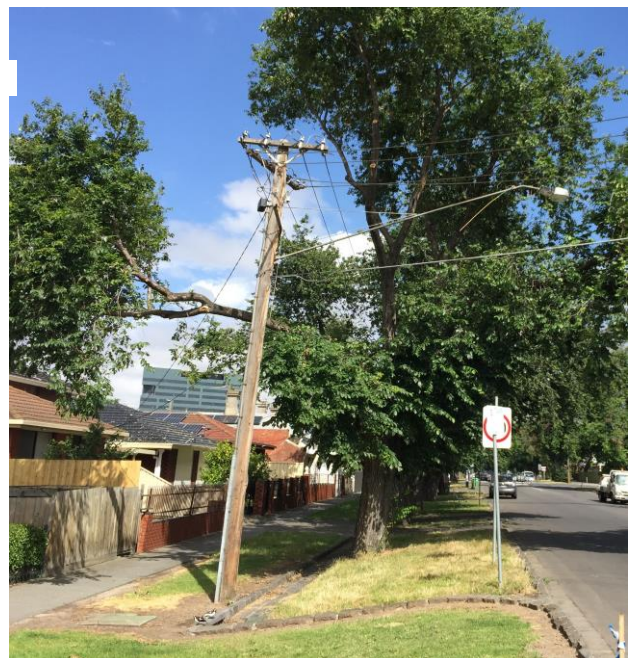
Tree Number: 29**Botanical Name:** *Ulmus procera***Common Name:** English Elm**Assessment Level:** Level 3 - Aerial Inspection**Height & Width (m):** 10 x 10**DBH (cm):** 92**Health:** Fair**Structure:** Poor**ULE:** Less than 5 years**Maturity:** Mature**Recommended Works:** Removal**Priority:** High**Failure Potential:** 2. High**Failure Size:** 2. 251-450mm**Target Occupancy:** 2. Pedestrians, 8-72/hr**Risk of Harm** **1 in 1,000****Risk Category:** Very high

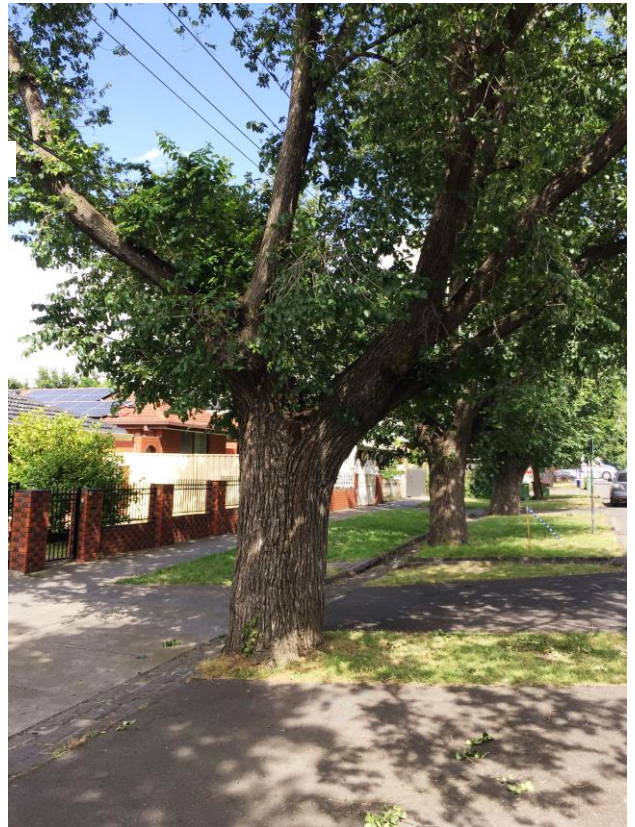
**Tree Number:** 30**Botanical Name:** *Ulmus procera***Common Name:** English Elm**Assessment Level:** Level 3 - Aerial Inspection, Tomograph**Height & Width (m):** 10 x 8**DBH (cm):** 89**Health:** Fair**Structure:** Poor**ULE:** 0 years**Maturity:** Mature**Recommended Works:** Removal**Priority:** High**Failure Potential:** 2. High**Failure Size:** 2. 251-450mm**Target Occupancy:** 2. Pedestrians, 8-72/hr**Risk of Harm** **1 in 1,000****Risk Category:** Very high

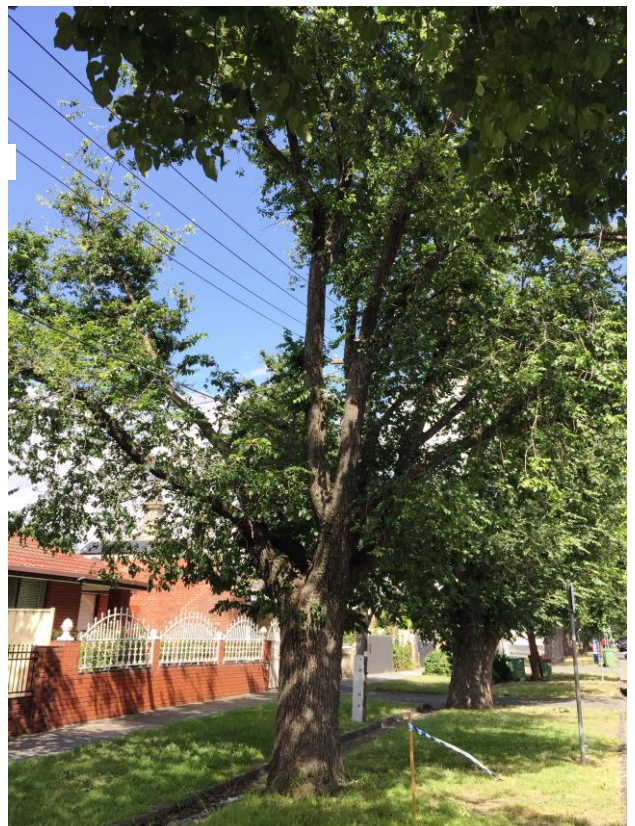
Tree Number: 31**Botanical Name:** *Ulmus procera***Common Name:** English Elm**Assessment Level:** Level 3 - Aerial Inspection**Height & Width (m):** 10 x 12**DBH (cm):** 100**Health:** Fair**Structure:** Poor**ULE:** 0 years**Maturity:** Mature**Recommended Works:** Removal**Priority:** High**Failure Potential:** 2. High**Failure Size:** 2. 251-450mm**Target Occupancy:** 2. Pedestrians, 8-72/hr**Risk of Harm** **1 in 1,000****Risk Category:** Very high

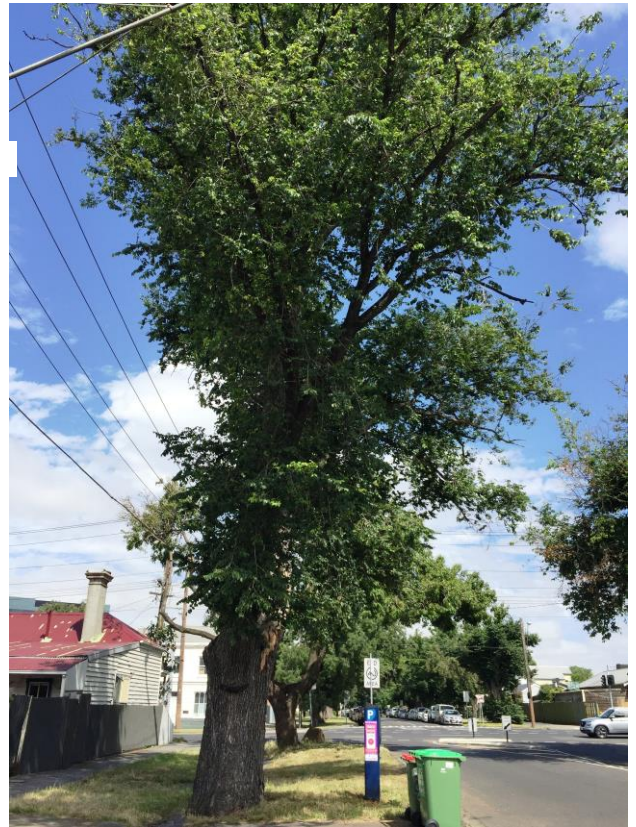
Tree Number: 34
Botanical Name: *Fraxinus angustifolia subsp. angustifolia*
Common Name: Desert Ash
Assessment Level: Level 3 - Tomograph
Height & Width (m): 11 x 12
DBH (cm): 80
Health: Fair
Structure: Fair
ULE: 10 to 20 years
Maturity: Mature
Recommended Works: No works
Priority: None
Failure Potential: 3. Moderate
Failure Size: 3. 101-250mm
Target Occupancy: 2. Pedestrians, 8-72/hr
Risk of Harm **1 in 50,000**
Risk Category: Moderate
Comments: Tomograph results show excellent condition at the test site

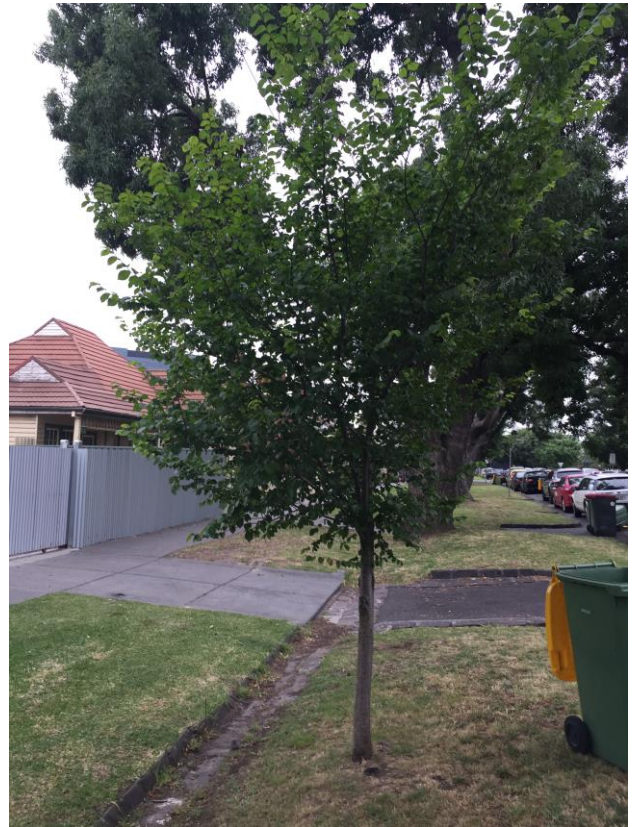
**Tree Number:** 38**Botanical Name:** *Fraxinus angustifolia subsp. angustifolia***Common Name:** Desert Ash**Assessment Level:** Level 2**Height & Width (m):** 15 x 11**DBH (cm):** 92**Health:** Fair**Structure:** Fair**ULE:** 20 to 40 years**Maturity:** Mature**Recommended Works:** 10% risk reduction pruning over road**Priority:** Moderate**Failure Potential:** 3. Moderate**Failure Size:** 3. 101-250mm**Target Occupancy:** 2. Pedestrians, 8-72/hr**Risk of Harm** **1 in 50,000****Risk Category:** Moderate**Comments:** Lionstailed branches

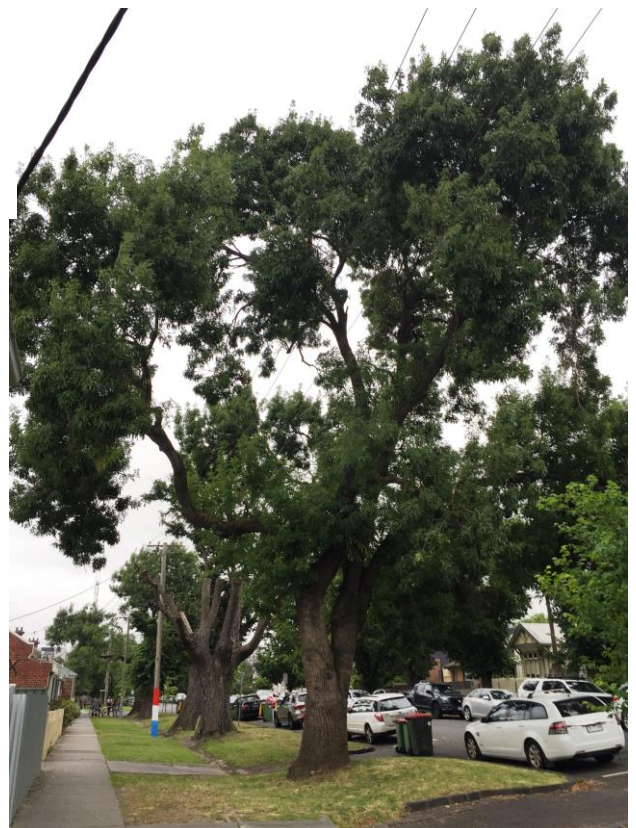
Tree Number:	39
Botanical Name:	<i>Ulmus procera</i>
Common Name:	English Elm
Assessment Level:	Level 2
Height & Width (m):	6 x 5
DBH (cm):	115
Health:	Poor
Structure:	Poor
ULE:	0 years
Maturity:	Mature
Recommended Works:	Removal
Priority:	High
Failure Potential:	4. Low
Failure Size:	4. 26-100mm
Target Occupancy:	2. Pedestrians, 8-72/hr
Risk of Harm	1 in 5,000,000
Risk Category:	Low
Comments:	Previous large limb failure - lopped at major limbs

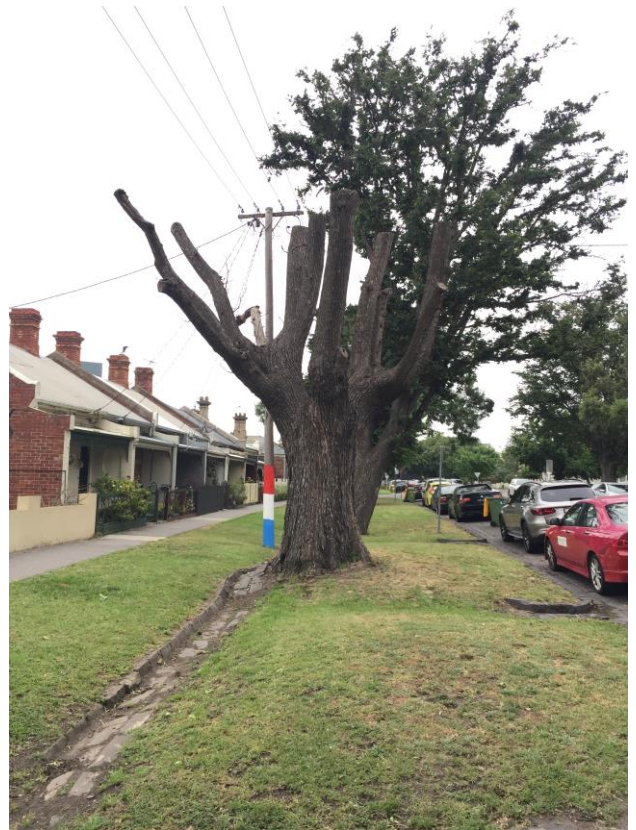
Tree Number:	40
Botanical Name:	<i>Ulmus procera</i>
Common Name:	English Elm
Assessment Level:	Level 2
Height & Width (m):	12 x 7
DBH (cm):	100
Health:	Poor
Structure:	Poor
ULE:	0 years
Maturity:	Mature
Recommended Works:	Removal
Priority:	High
Failure Potential:	2. High
Failure Size:	2. 251-450mm
Target Occupancy:	2. Pedestrians, 8-72/hr
Risk of Harm	1 in 1,000
Risk Category:	Very high
Comments:	Declining in health and with significant lean. Previous root plate movement.

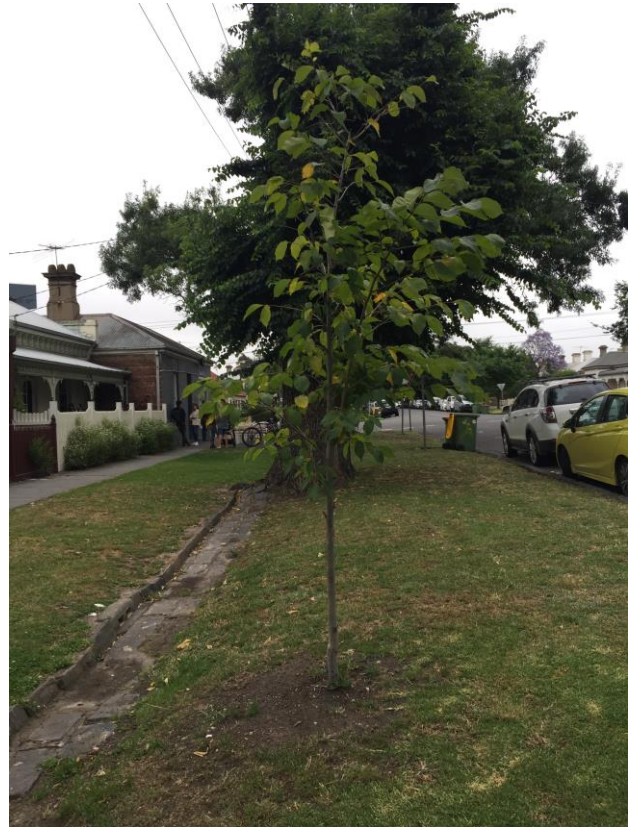
**Tree Number:** 42**Botanical Name:** *Ulmus procera***Common Name:** English Elm**Assessment Level:** Level 2**Height & Width (m):** 7 x 4**DBH (cm):** 116**Health:** Poor**Structure:** Poor**ULE:** 0 years**Maturity:** Mature**Recommended Works:** Removal**Priority:** High**Failure Potential:** 4. Low**Failure Size:** 4. 26-100mm**Target Occupancy:** 2. Pedestrians, 8-72/hr**Risk of Harm** 1 in 5,000,000**Risk Category:** Low**Comments:** Lopped

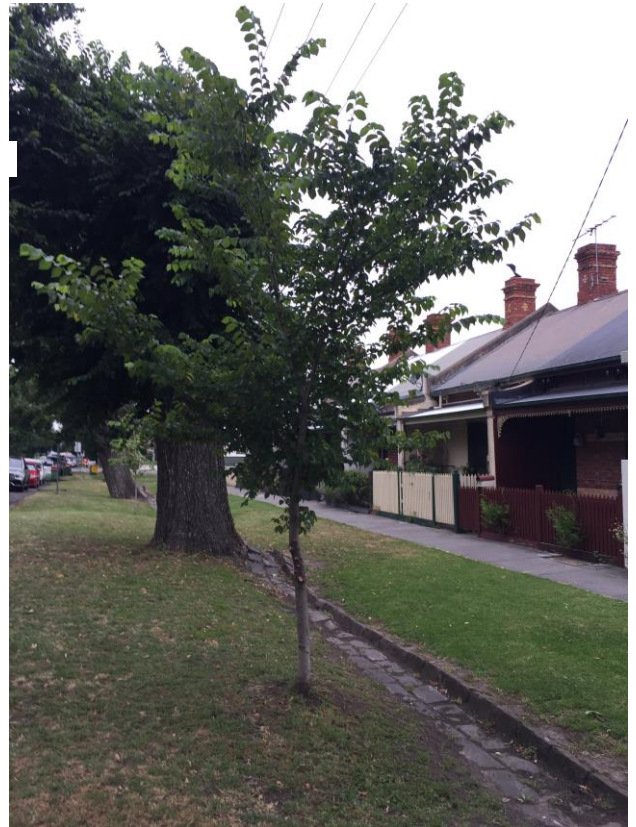
**Tree Number:** 44**Botanical Name:** *Fraxinus angustifolia subsp. angustifolia***Common Name:** Desert Ash**Assessment Level:** Level 2**Height & Width (m):** 13 x 15**DBH (cm):** 85**Health:** Good**Structure:** Fair**ULE:** 20 to 40 years**Maturity:** Mature**Recommended Works:** Deadwood removal, Canopy lift**Priority:** Moderate**Failure Potential:** 3. Moderate**Failure Size:** 3. 101-250mm**Target Occupancy:** 2. Human Occupancy, 2.5hrs/day to 15**Risk of Harm** **1 in 50,000****Risk Category:** Moderate**Comments:** Lift over property

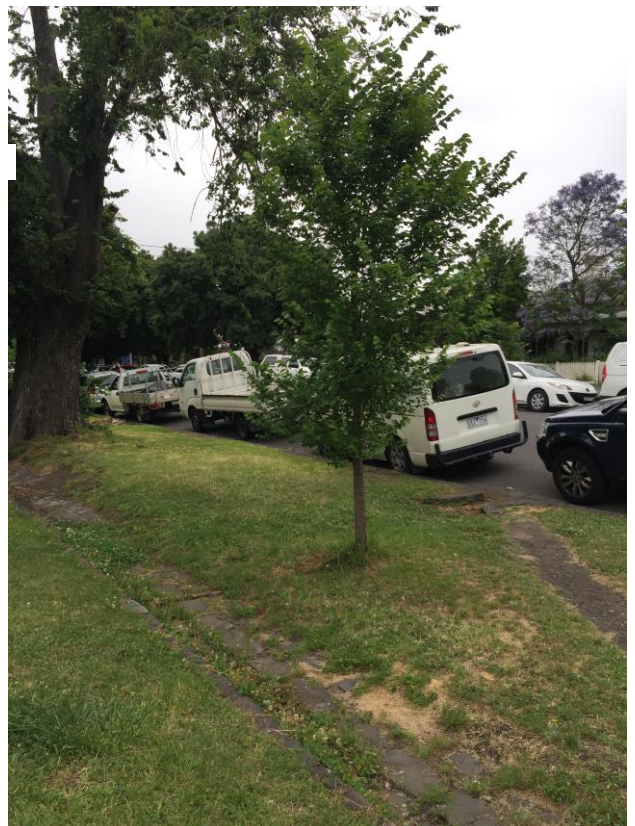
Tree Number: 47**Botanical Name:** *Ulmus procera***Common Name:** English Elm**Assessment Level:** Level 3 - Aerial Inspection**Height & Width (m):** 12 x 14**DBH (cm):** 126**Health:** Fair**Structure:** Poor**ULE:** 0 years**Maturity:** Mature**Recommended Works:** Removal**Priority:** High**Failure Potential:** 2. High**Failure Size:** 3. 101-250mm**Target Occupancy:** 2. Pedestrians, 8-72/hr**Risk of Harm** **1 in 5,000****Risk Category:** High**Comments:** Lost large limb recently, has been lopped on one side
