**PICUS SONIC TOMOGRAPH TEST (ST) SUMMARY REPORT.**

**COMPLETED FOR: MARIBYRNONG CITY COUNCIL**

**LOCATION: BUNBURY STREET, FOOTSCRAY**

**DATE: 12<sup>TH</sup> & 13<sup>TH</sup> JANUARY 2022**

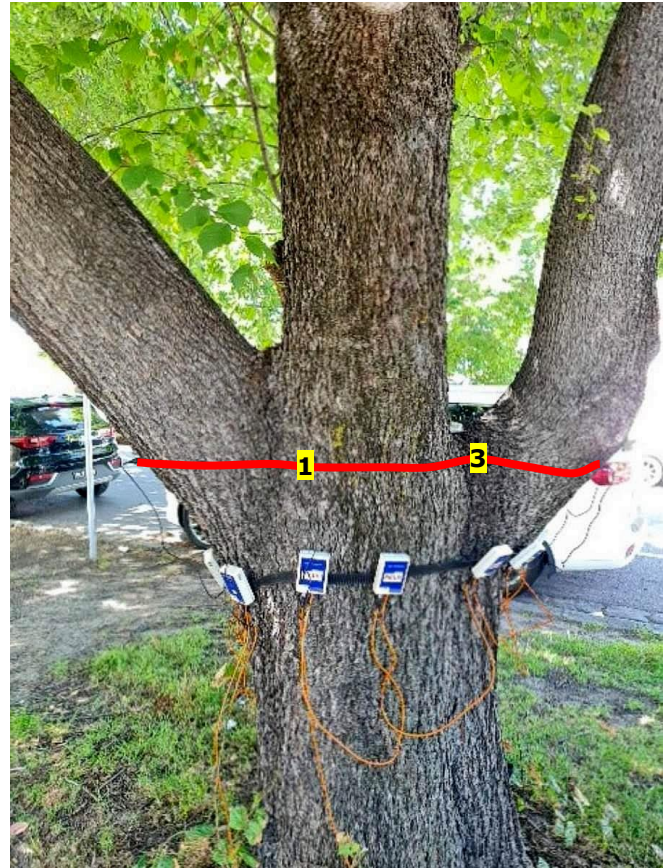
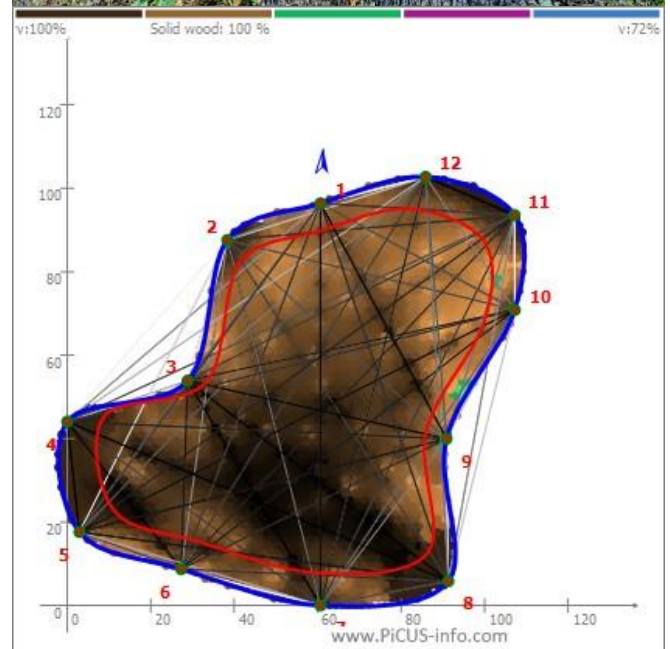
**1250mm above ground level at sensor one**

The Sonic Tomograph test result indicates that approximately 100% of the test area is sound (high density) wood, and there is less than 1% of incipient wood (wood being altered by the fungus). The test result shows no active fungus and decayed (low density) wood at the test height.

The tree has multiple trunks with unions traversing the test height from sensor 3 to sensor 6, and from sensors above 9-10 through to sensors 12-1. The test result shows that there is no degradation to the structural integrity of the trunk at the test height.

The test result shows some minor incipient wood in the sapwood between and around sensors 9 and 10. It is likely that these spots are minor imperfections in the sapwood caused by insects etc. These spots of incipient wood were not assessed as a structural issue and will likely compartmentalise.

It is observed that new wood growth increments are occurring at sensors 2, 4, 5, 8, 11 and 12.

The tree displays health and vigour that is typical for the species and the test result provides evidence that the tree is in excellent condition and is structurally sound at the test height.

The tree has an estimated life expectancy of greater than 50 years at the test point. It is recommended that the tree is retested in 10 years to assess the structural integrity of the trunk at the test height.

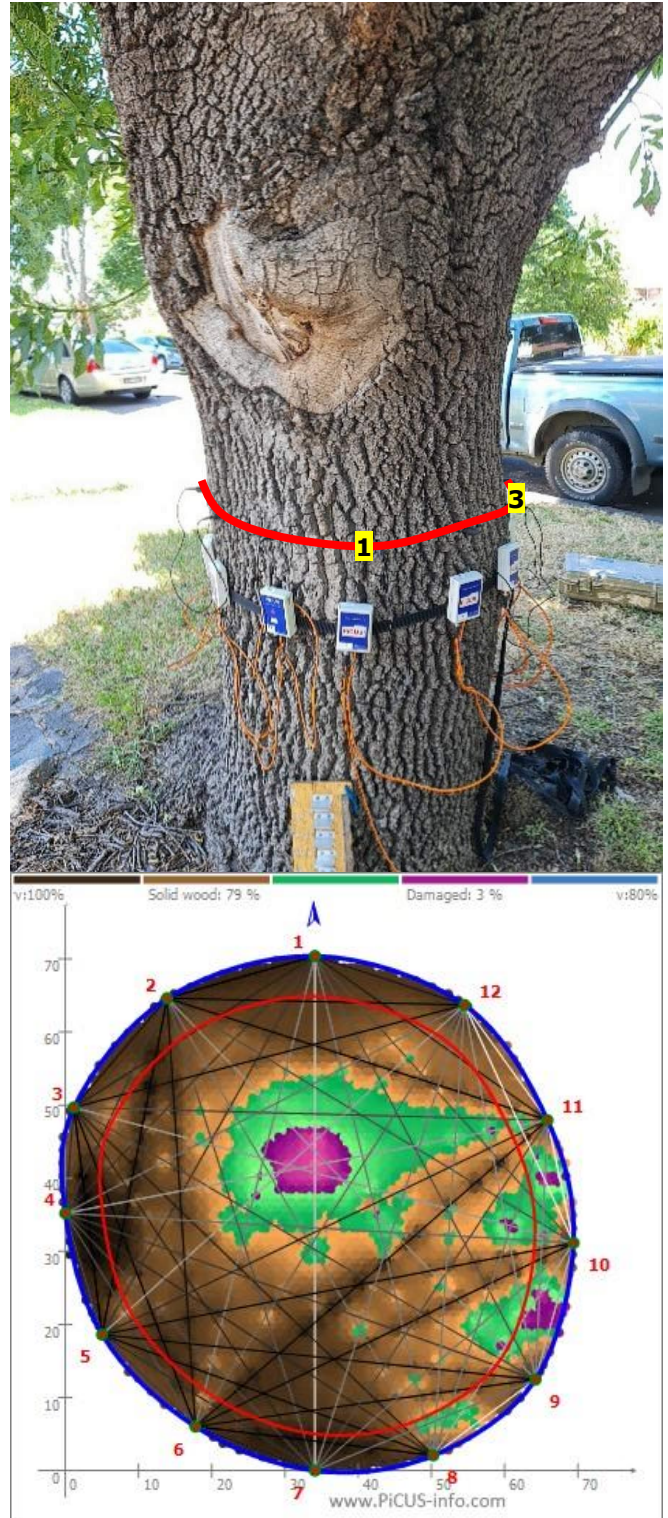
### 1000mm above ground level at sensor one

The Sonic Tomograph test result indicates 79% of the test area is sound (high density) wood. There is 18% of incipient wood (wood being altered by the fungus). The remaining 3% is active fungus and decayed (low density) wood.

The incipient and dysfunctional wood in the test result in the centre of the trunk, has likely entered the centre pith of the tree through the root plate. Pith is composed of soft, spongy parenchyma cells, which store and transport nutrients throughout the plant. In trees pith is present in young growth, and as the tree matures the pith gets replaced by xylem leaving the pith to dry out and degrade creating an opportunity for soil borne fungi to enter the trunk. The pathogen can then move up the trunk via the centre pith. This type of centre pith wood degradation is a common event in the lifecycle of trees.

The test result shows some minor pockets of incipient and dysfunctional wood in the sapwood on the eastern side of the trunk between sensors 8 and 11. It is likely that these spots are minor imperfections in the sapwood caused by insects/past wounds etc. At the time of the test, these areas of incipient and dysfunctional wood were not assessed as structural issues and will likely compartmentalise.

The test result shows that there is sufficient sound wood to maintain structural support for the tree at the test height. Additionally, it is observed that new wood growth increments are occurring at sensors 3, 4, 6 and 7.

The tree displays health and vigour that is typical for the species and the test result provides evidence that the tree is in very good condition and is structurally sound at the test height.

The tree has an estimated life expectancy of greater than 30 years at the test point. It is recommended that the tree is retested in 3 years to assess the progression of the pathogen and to re-evaluate the structural integrity of the trunk at the test height.

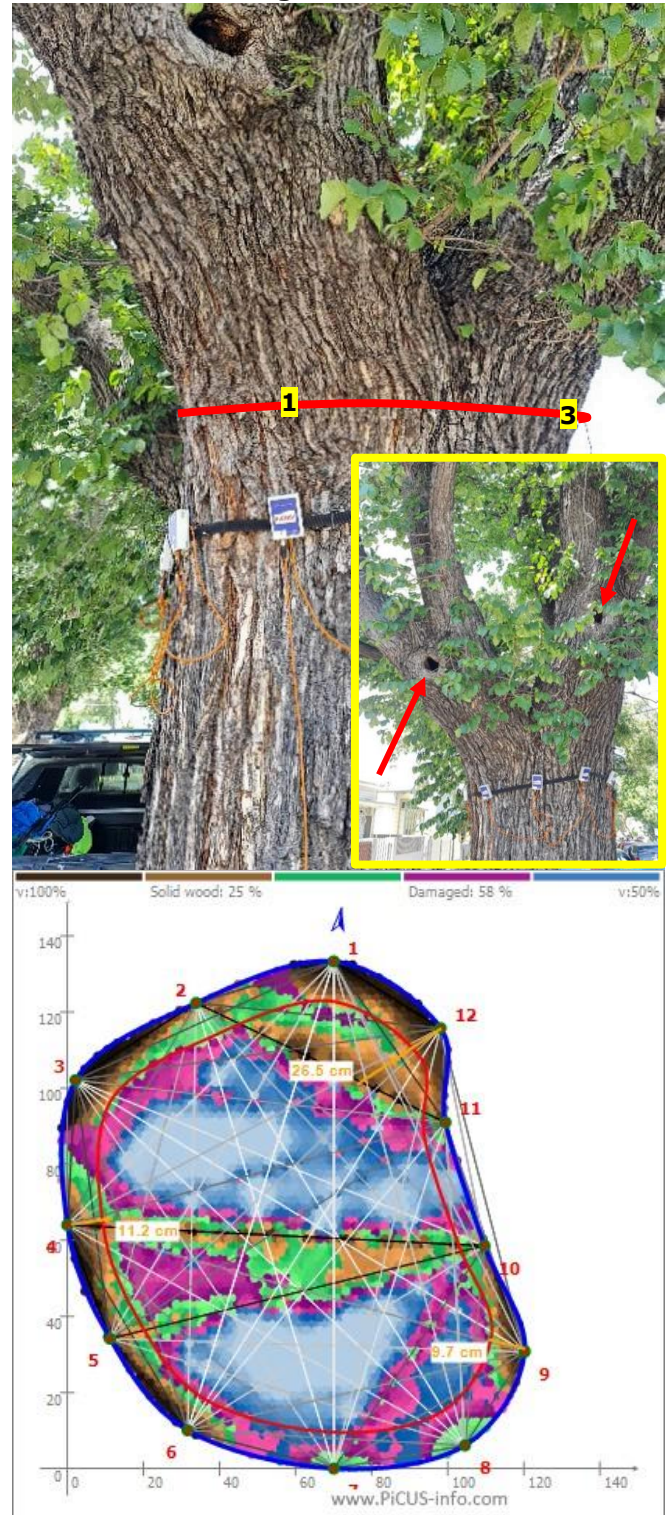
2500mm above ground level at sensor one

The Sonic Tomograph test result indicates 25% of the test area is sound (high density) wood. There is 17% of incipient wood (wood being altered by the fungus). The remaining 58% is active fungus and decayed (low density) wood.

The tree has been pollarded in the past above the test height at approximately 3.5 metres above ground level. Decay was observed in some of the old pruning wounds at the old pollarding points (red arrows in picture in yellow box indicate decay in some of the old pruning wounds). It is likely that the decay causing pathogen has spread into the trunk from the old pollarding points resulting the incipient and dysfunctional wood shown in the test result.

The primary union of the pollard heads traverses the test point from sensor 2 through to sensor 7. The test result shows that the pathogen has caused significant degradation to the structural integrity of the primary union.

Additionally, the test result shows that the dysfunctional wood has encroached into the t/R ratio (set at 15%). The t/R ratio is only used as a guide to evaluate the sound wood/dysfunctional wood ratio and should not be used as an index of trunk failure potential. However, there is very limited structural wood, particularly on the southern and eastern sides of the test point, with a very high percentage of the trunk area assessed as non-functional wood.

Although the test result shows new wood growth increments are occurring at sensors 1, 3, 4, 6, 9 and 12, the extent of the dysfunctional wood at the test height was assessed as a structural defect in the trunk.

The tree is recommended for removal because of its poor canopy management history and reduced life expectancy due to the extent of trunk decay.

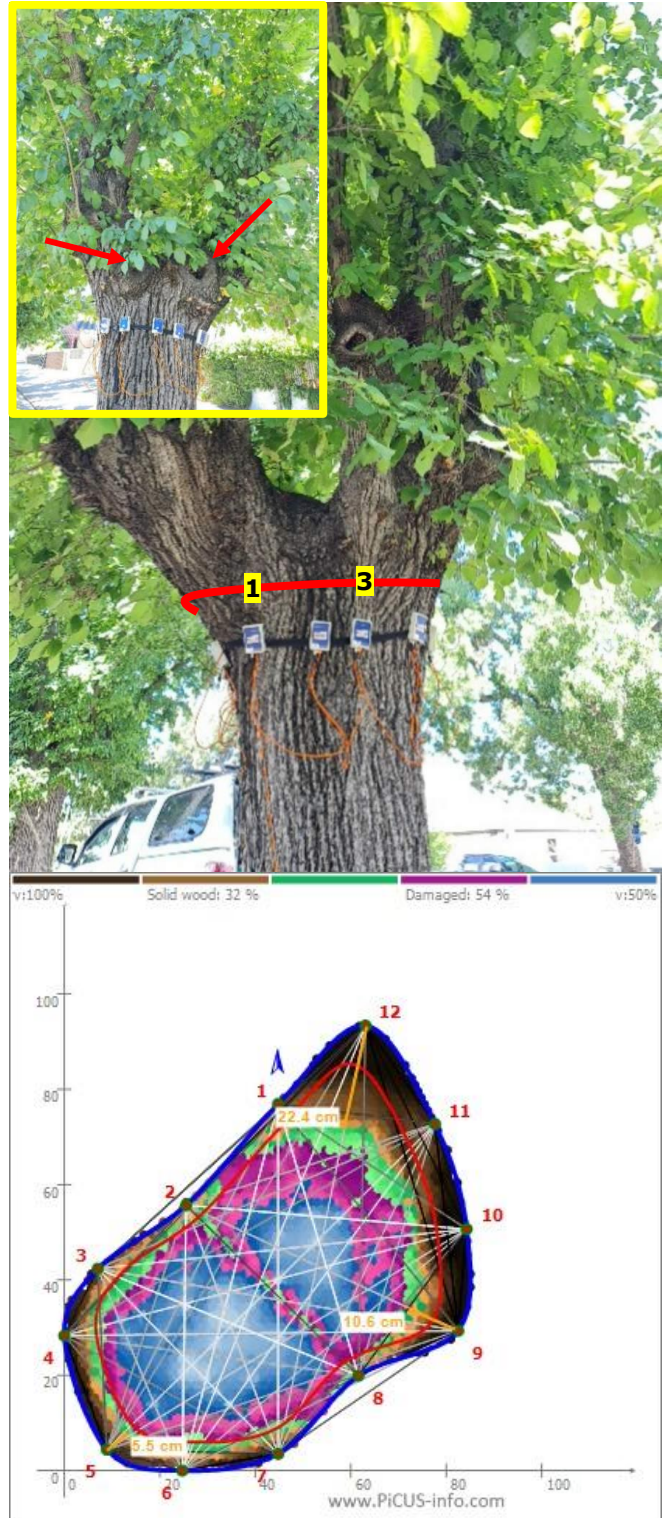
**2100mm above ground level at sensor one**

The Sonic Tomograph test result indicates 32% of the test area is sound (high density) wood. There is 14% of incipient wood (wood being altered by the fungus). The remaining 54% is active fungus and decayed (low density) wood.

The tree has been pollarded in the past above the test height at approximately 3.5 metres above ground level with the primary union of the pollard heads traversing the test point from sensor 2 through to sensor 8. Decay was observed in some of the old pruning wounds at the old pollarding points and it is likely that the pathogen has spread into the trunk from the old pollarding points. Additionally, decay was observed in old pruning wounds close to the primary union on the southern side of the tree (red arrows in picture in yellow box indicate decay in some of the old pruning wounds). The test result shows that the pathogen has spread through the heartwood on the trunk reaching the outer trunk wall between sensors 1 and 2; and between sensors 7 and 8.

Of concern is the degradation to the structural integrity of the tension wood in the primary union caused by the decay and dysfunctional wood. In angiosperms (flowering plants/trees), reaction wood is formed in the tension wood in response to load. The test result shows that the tension wood of the primary union is virtually completely degraded, and the limited compression wood of the primary union and pollard heads is providing some structural support for the union. At the test height, the test result shows at sensor 5 there is 5 cm of sound compression wood; and at sensor 12 there is 22 cm of sound compression wood. The pathogen reaching the outer trunk wall around sensors 2 and 8 has significantly reduce the potential for the tree to develop reaction wood in the tension wood of the primary union; this was assessed as a structural defect.

The tree is recommended for removal because of its poor canopy management history and reduced life expectancy due to the extent of trunk decay.

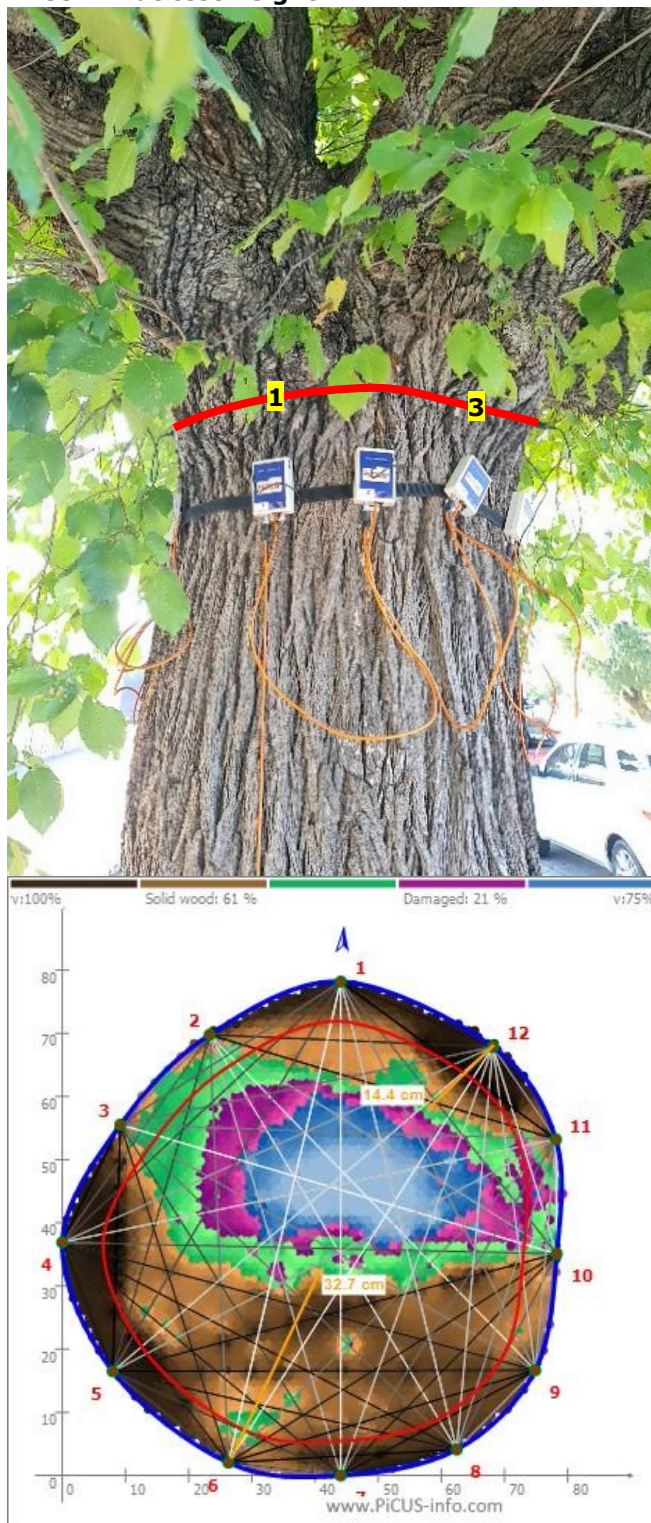
### 2300mm above ground level at sensor one

The Sonic Tomograph test result indicates 61% of the test area is sound (high density) wood. There is 18% of incipient wood (wood being altered by the fungus). The remaining 21% is active fungus and decayed (low density) wood.

The pathogen in the test result has likely entered the tree through the pruning wounds from the past pollarding of the tree. The incipient and dysfunctional seen in the test result has been caused by the spread of the pathogen from the pollard heads above the test point.

The test result shows that pathogen has caused some minor degradation to the structural integrity of the primary union; however, there is sufficient sound compression wood to maintain structural support for the union. At the test height, the test result shows at sensor 6 there is 32 cm of sound compression wood; and at sensor 12 there is 14 cm of sound compression wood.

The tree displays health and vigour that is typical for the species and the test result provides evidence that the tree is in very good condition and is structurally sound at the test height.

The tree has an estimated life expectancy of greater than 20 years at the test point. It is recommended that the tree is retested in 3 years to assess the progression of the pathogen and to re-evaluate the structural integrity of the trunk at the test height.

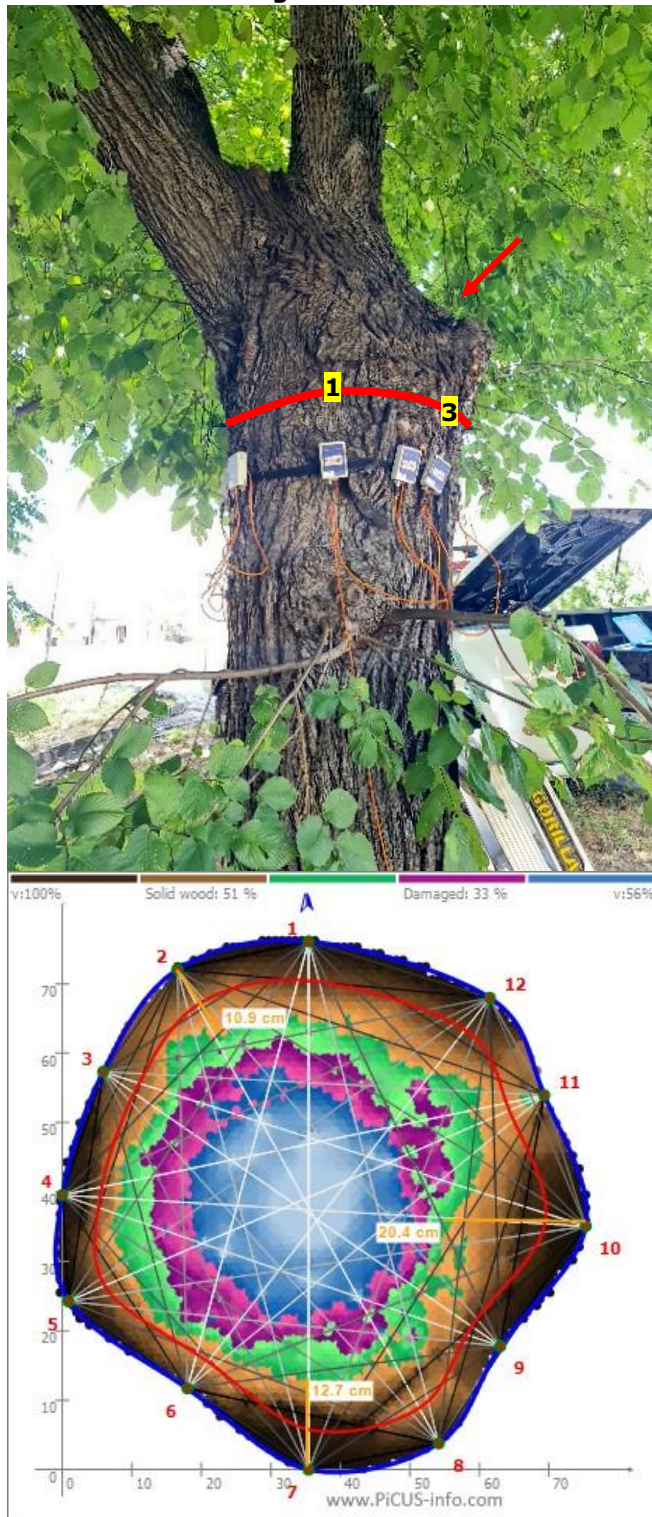
2300mm above ground level at sensor one

The Sonic Tomograph test result indicates 51% of the test area is sound (high density) wood. There is 16% of incipient wood (wood being altered by the fungus). The remaining 33% is active fungus and decayed (low density) wood.

The tree has been pollarded in the past above the test height at approximately 3 metres above ground level. Additionally, it appears that a scaffold limb/pollard head on the western side of the tree has been removed in the past (indicated by red arrow in photograph). The wound has occluded, and it could not be determined at the time of the assessment whether the removal of this part of the tree was due to a failure or tree management.

The test result indicates that the pathogen is contained to the heartwood of the trunk at the test height causing some degradation to the structural integrity of the trunk at the test height. However, the test result shows that there is sufficient sound wood to maintain structural support for the tree at the test height. At the test height, the test result shows at sensor 2 there is 10 cm of sound wood; at sensor 7 there is 12 cm of sound wood; and at sensor 10 there is 20 cm of sound wood. Furthermore, it is observed that new wood growth increments are occurring in the trunk at sensors 1, 2, 4, 5, 7, 8, 9, 10 and 12.

The tree displays health and vigour that is typical for the species and the test result provides evidence that the tree is in good condition and is structurally sound at the test height.

The tree has an estimated life expectancy of greater than 20 years at the test point. It is recommended that the tree is retested in 3 years to assess the progression of the pathogen and to re-evaluate the structural integrity of the trunk at the test height.

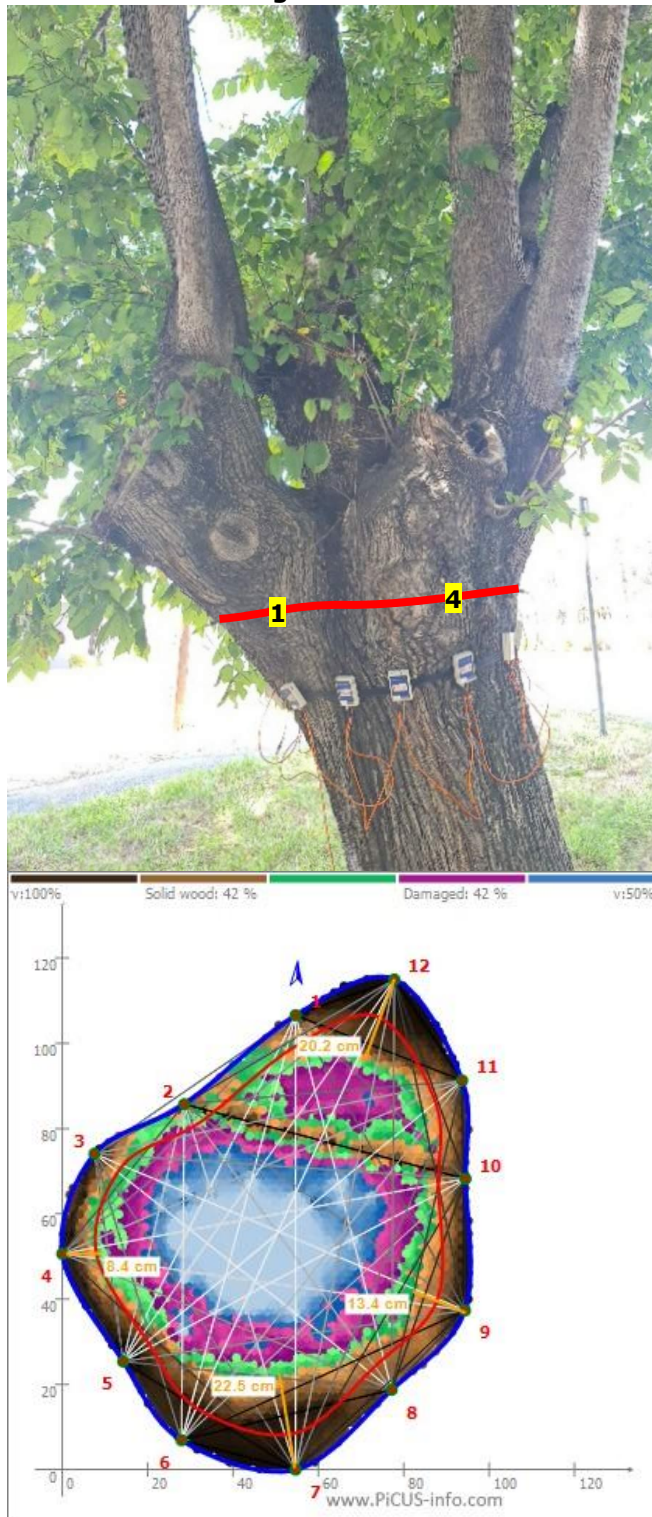
**1900mm above ground level at sensor one**

The Sonic Tomograph test result indicates 42% of the test area is sound (high density) wood. There is 16% of incipient wood (wood being altered by the fungus). The remaining 42% is active fungus and decayed (low density) wood.

The tree has been pollarded in the past above the test height at approximately 2.5 metres above ground level. Decay was observed in some of the old pruning wounds of the pollard heads. It is likely that the pathogen has entered the tree through these old pruning wounds and the incipient and dysfunctional seen in the test result is associated with this pathogen spreading from the old pruning wounds.

The primary unions of the pollard heads intersects with the outer trunk at sensors 2, 8 and 10. Although, the test result shows that the pathogen is largely contained to the heartwood of the trunk at the test point, the pathogen has caused degradation to the tension wood of the primary unions of the pollard heads. However, there is sound wood in the compression wood of the unions/pollard heads providing structural support for the unions. At the test height, the test result shows at sensor 7 there is 22 cm of sound wood; at sensor 9 there is 13 cm of sound wood; and at sensor 12 there is 20 cm of sound wood. Furthermore, it is observed that new wood growth increments are occurring at sensors 4, 5, 6, 7, 9 and 12.

The test result provides evidence that the tree is structurally sound at the test height. The tree has estimated life expectancy of less than 10 years at the test point. It is acknowledged that the tree could be retained in the short-term, but its removal may be warranted because of its poor canopy management history and reduced life expectancy due to the extent of trunk decay effecting the structural integrity of the primary unions.

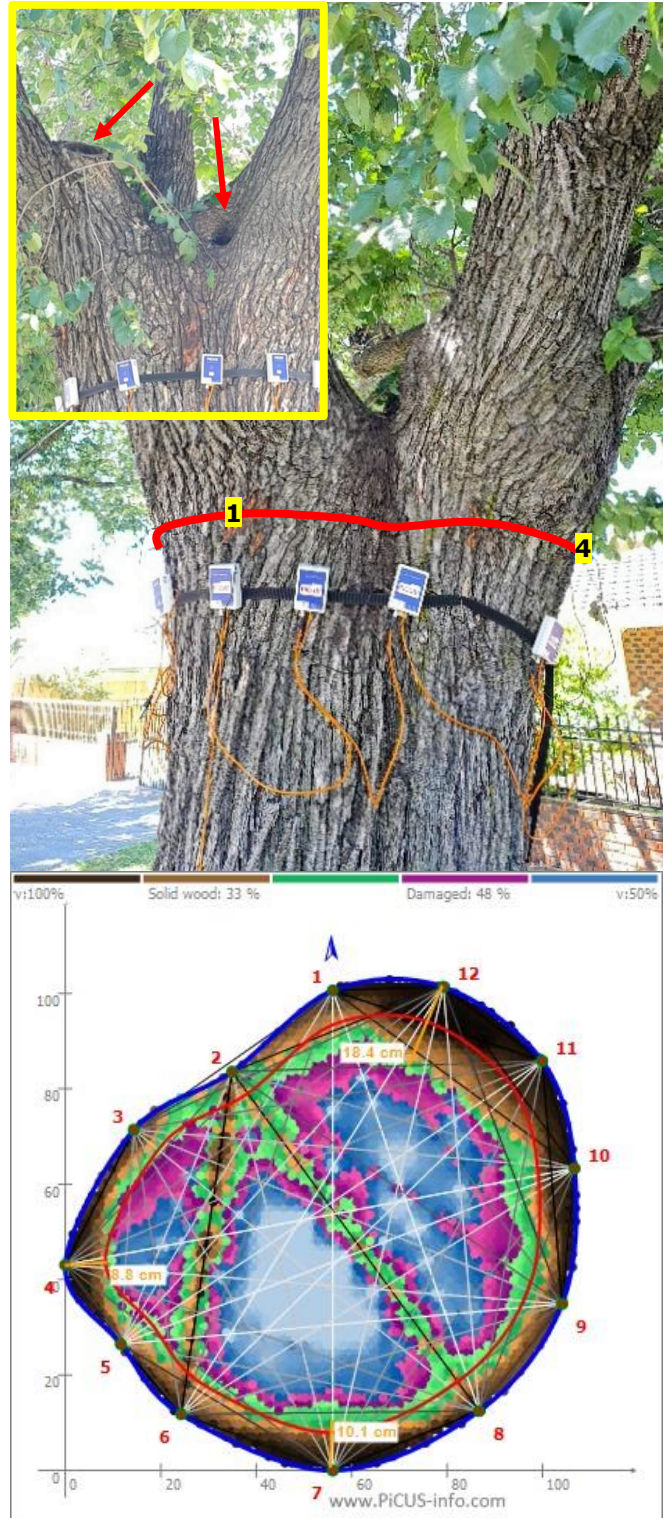
### 2200mm above ground level at sensor one

The Sonic Tomograph test result indicates 33% of the test area is sound (high density) wood. There is 19% of incipient wood (wood being altered by the fungus). The remaining 48% is active fungus and decayed (low density) wood.

The tree has been pollarded in the past above the test height at approximately 3.5 metres above ground level. Furthermore, the tree has been routinely pruned for line clearance. Decay was observed in some of the old pruning wounds (red arrows in photo in yellow box indicate some of the decay in old pruning wounds). The incipient and dysfunctional seen in the test result is associated with the pathogen spreading from the old pruning wounds above the test height.

The primary union of the pollard heads traverses the test height from sensor 2 through to sensors 8-9. Although, the test result shows that the pathogen is largely contained to the heartwood of the trunk at the test point, the pathogen has caused degradation to the tension wood of the primary unions of the pollard heads. However, there is sound compression wood of the unions/pollard heads providing structural support for the unions. At the test height, the test result shows at sensor 4 there is 8 cm of sound wood; at sensor 7 there is 10 cm of sound wood; and at sensor 12 there is 18 cm of sound wood. Furthermore, it is observed that new wood growth increments are occurring at sensors 4, 7, 9 and 12.

The test result provides evidence that the tree is structurally sound at the test height. The tree has estimated life expectancy of less than 10 years at the test point. It is acknowledged that the tree could be retained in the short-term, but its removal may be warranted because of its poor canopy management history and reduced life expectancy due to the extent of trunk decay effecting the structural integrity of the primary unions.

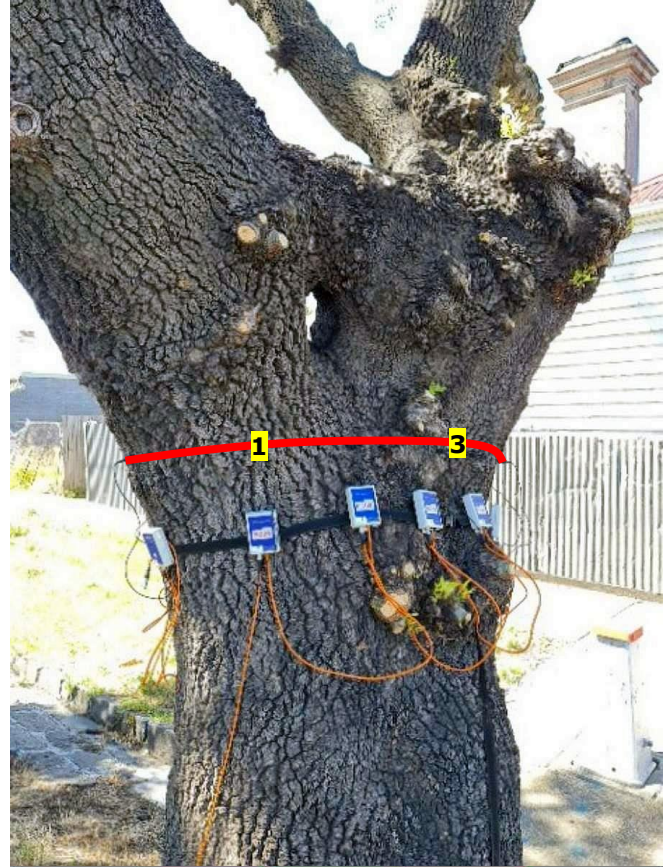
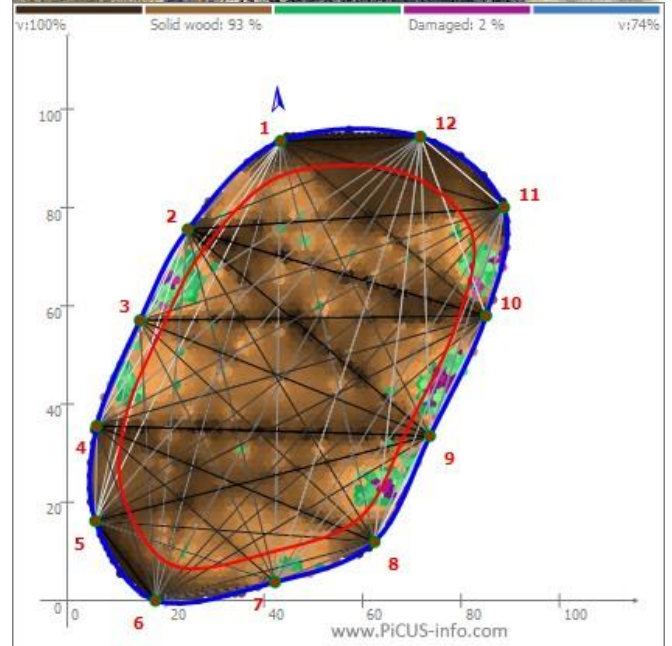
1600mm above ground level at sensor one

The Sonic Tomograph test result indicates 93% of the test area is sound (high density) wood. There is 5% of incipient wood (wood being altered by the fungus). The remaining 2% is active fungus and decayed (low density) wood.

The test result shows that there is negligible degradation to the structural integrity of the trunk at the test height.

The test result shows some minor incipient wood in the sapwood between sensors 2 and 4; and between sensors 8 and 11. It is likely that these spots of low-density wood are areas of latent buds' activity (between sensors 2 and 3) and minor imperfections caused by old wounds (sensors 8 to 11) etc. These spots of incipient wood were not assessed as structural issues and will compartmentalise.

It is observed that new wood growth increments are occurring in the compression wood of the scaffold branches at sensors 1, 5, 6, 8, 11 and 12.

The tree has an estimated life expectancy of greater than 40 years at the test point. It is recommended that the tree is retested in 5 years to assess the progression of the pathogen and to structural integrity of the trunk at the test height.

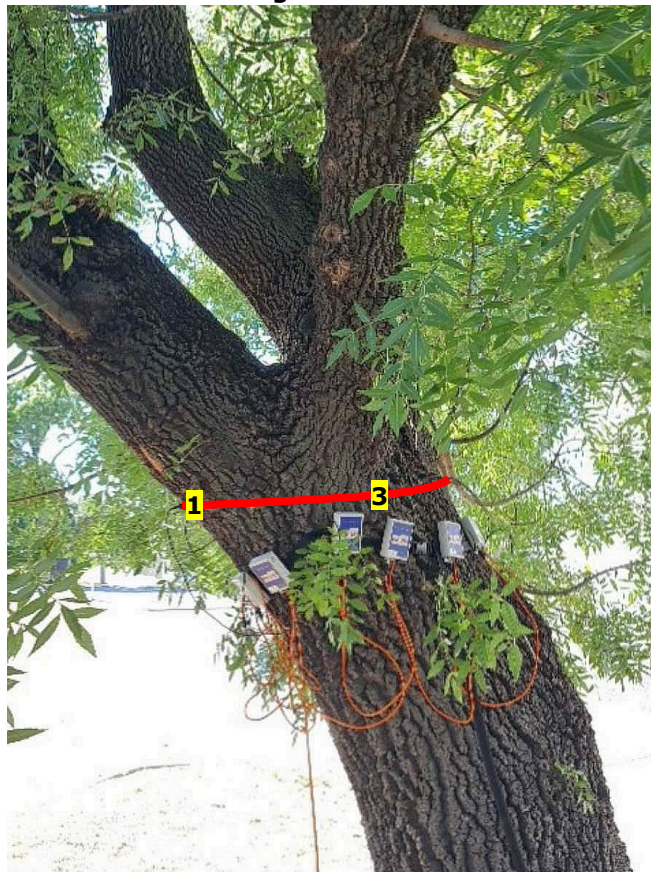
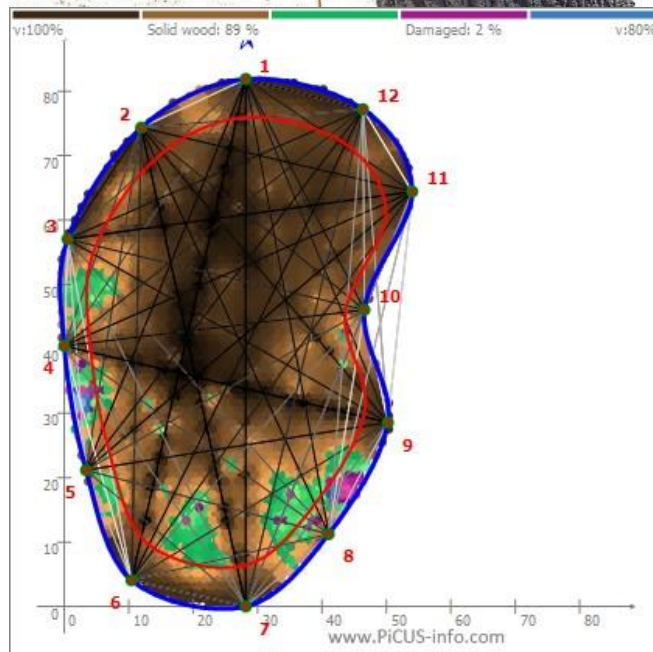
2000mm above ground level at sensor one

The Sonic Tomograph test result indicates 89% of the test area is sound (high density) wood. There is 9% of incipient wood (wood being altered by the fungus). The remaining 2% is active fungus and decayed (low density) wood.

The test result shows some minor areas of incipient and dysfunctional wood in the sapwood between sensors 1 and 9. The test result shows that some of this of incipient and dysfunctional wood has encroached into the heartwood (sensor 6 to sensor 8) at the test height. It is likely that these areas are minor imperfections in the wood caused by old wound, insects etc.

It is observed that new wood growth increments are occurring in the tension wood at sensors 6, 7 and 9; and in the compression wood at sensors 11, 12, 1 and 2.

The tree displays health and vigour that is typical for the species and the test result provides evidence that the tree is in very good condition and is structurally sound at the test height.

The tree has an estimated life expectancy of greater than 40 years at the test point. It is recommended that the tree is retested in 5 years to assess the progression of the pathogen and to structural integrity of the trunk at the test height.

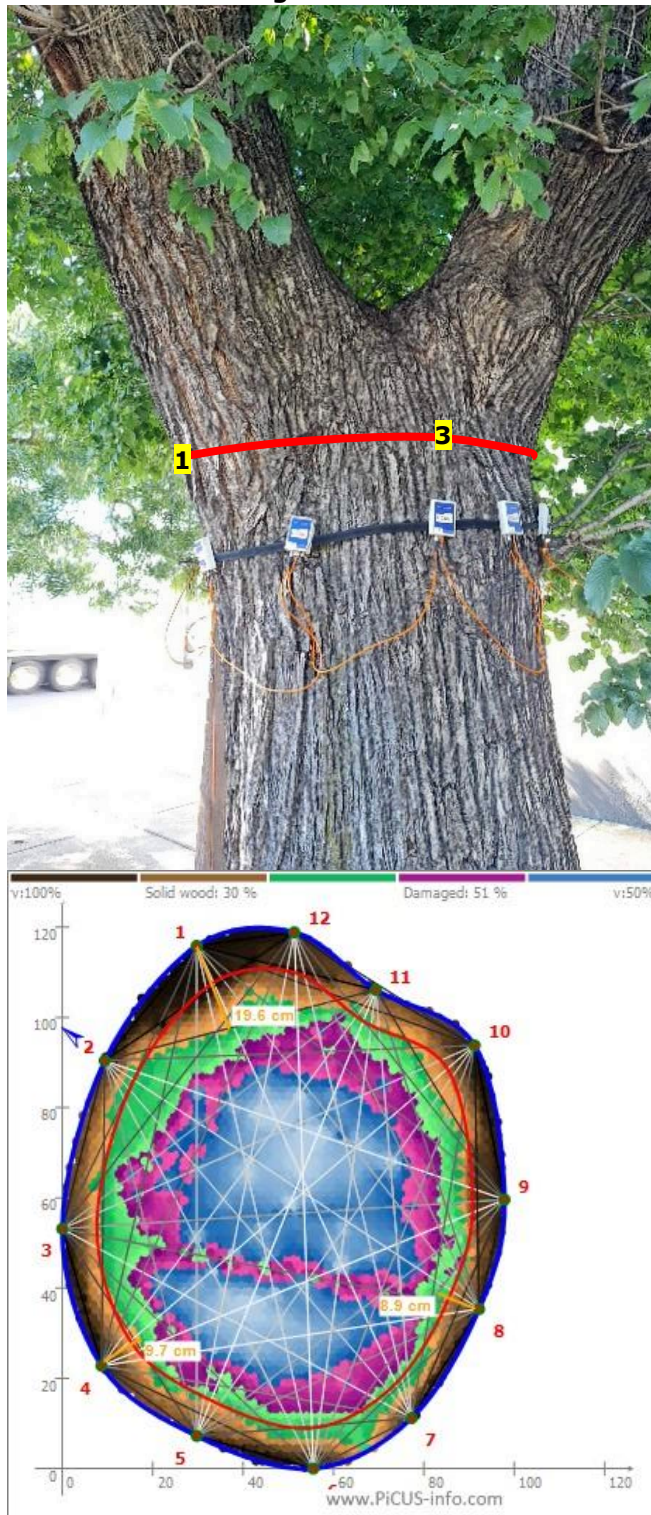
2300mm above ground level at sensor one

The Sonic Tomograph test result indicates 30% of the test area is sound (high density) wood. There is 19% of incipient wood (wood being altered by the fungus). The remaining 51% is active fungus and decayed (low density) wood.

The tree has been pollarded in the past above the test height at approximately 3.5 metres above ground level. Furthermore, the tree has been routinely pruned for line clearance. Decay was observed in some of the old pruning wounds. The incipient and dysfunctional wood seen in the test result is associated with the pathogen spreading from the old pruning wounds above the test height. The primary union of the pollard heads traverses the test height from sensor 3 through to sensors 10. The pathogen has spread extensively through the heartwood of the trunk at the test height and is impacting upon the tension wood of the primary union of the pollard heads. However, the test result shows that there is some structural tension wood at sensor 3 and sensor 10 providing support for the union. Additionally, the scaffold limbs arising from the pollard heads have a largely upright habit, thus limiting the lateral load on the primary union.

However, it is acknowledged that the tree could be retained in the short-term, but its removal may be warranted because of its poor canopy management history and reduced life expectancy due to the extent of trunk decay affecting the structural integrity of the primary unions.

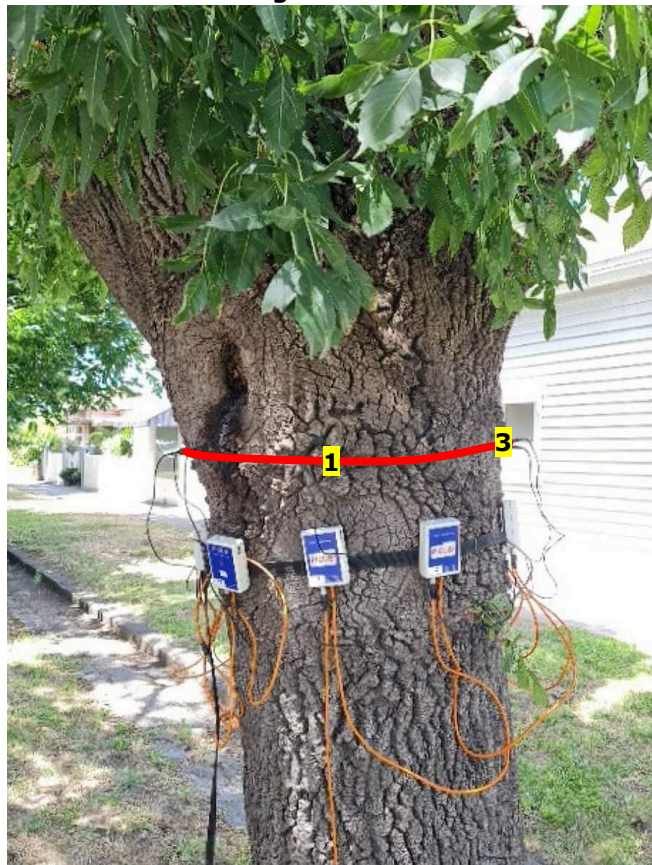
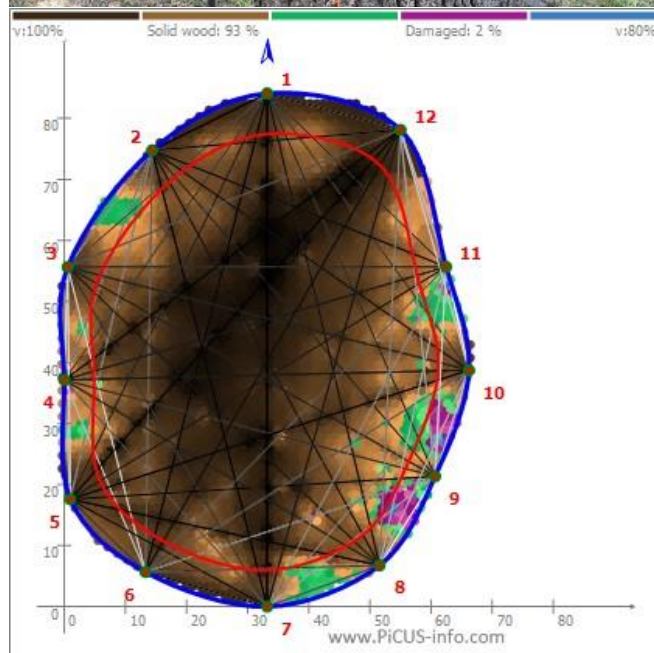
1700mm above ground level at sensor one

The Sonic Tomograph test result indicates 93% of the test area is sound (high density) wood. There is 5% of incipient wood (wood being altered by the fungus). The remaining 2% is active fungus and decayed (low density) wood.

The test result shows some minor areas of incipient and dysfunctional wood in the sapwood between sensors 2 and 5; and between sensors 7 and 11. It is likely that these areas are minor imperfections in the wood caused by old wound, insects etc. This incipient and dysfunctional wood were not assessed as a structural issue and will likely compartmentalise.

The test result shows that there is negligible degradation to the structural integrity of the trunk and that there is sufficient sound wood to maintain structural support for the trunk at the test height. It is observed that new wood growth increments are occurring at sensors 1, 2, 5, 7, 10 and 12.

The tree displays health and vigour that is typical for the species and the test result provides evidence that the tree is in excellent condition and is structurally sound at the test height.

The tree has an estimated life expectancy of greater than 40 years at the test point. It is recommended that the tree is retested in 5 years to assess the progression of the pathogen and to structural integrity of the trunk at the test height.
