**38-40 Moreland Street, Footscray**

A multi-storey mixed-use building is proposed for construction at the above address. Ground floor use would be commercial, with seven stories of residential apartments above.

Condition 14 of Maribyrnong City Council Planning Permit Application No. TP262/2024(1) requires "*An Environmental Site Assessment detailing the likelihood of contamination in accordance with point 6 (Application Requirements) of Schedule 1 to clause 37.08*".

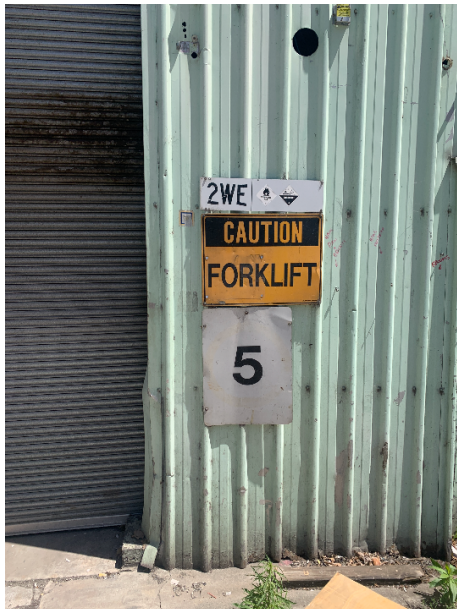
- There was no evidence identified relating to the presence of below ground infrastructure such fuel storage tanks or waste pits. No fill points, dip points, vent lines or bowser footprints were identified internally or external to the existing buildings and infrastructure.
- It is noted that previous site activities has included the storage and use of flammable gas and corrosive materials liquids as evidenced by the signage in the photos below:

*Photo 1 Central roller door entrance to warehouse.*

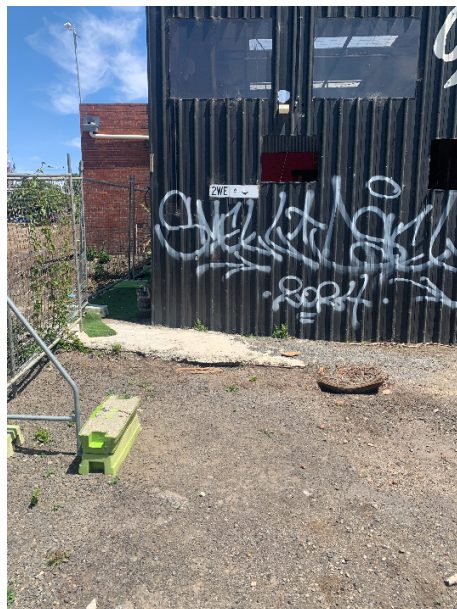
*Photo 2 – Western wall of south eastern extension*

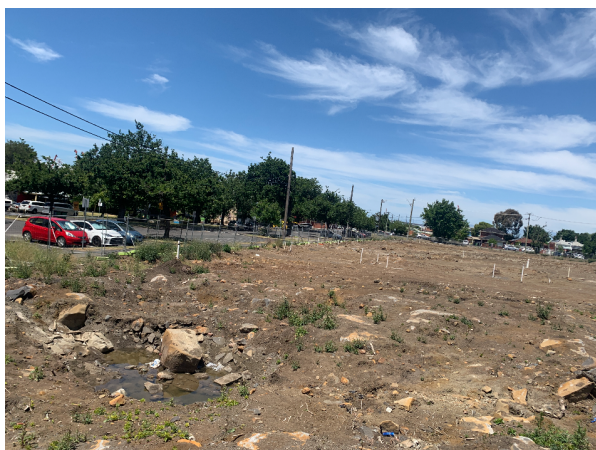
- It is also noted that the adjacent site to the south is being prepared for a proposed medium-high density residential development. Numerous groundwater monitoring wells and soil vapour bores have been installed at the site, as depicted in the photos below (indicating the presence of site contamination).

*Photo 3 Eastern portion of development site*

As would have been the case for the former Ryco site to the south, more detailed site assessment works at the subject could be undertaken as part of future planning permit condition requirements.

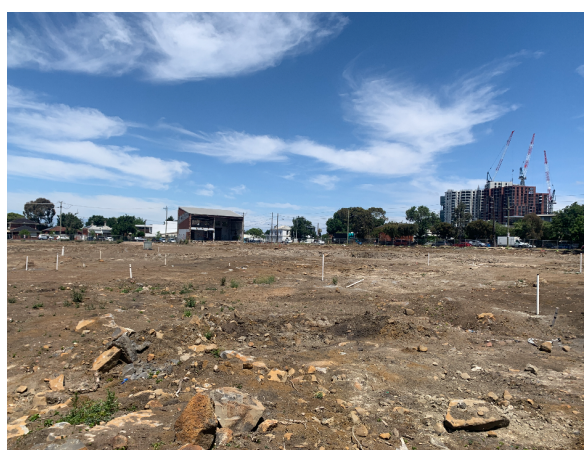
*Photo 4 – Western portion of development site*
