Risk Assessment and Recommended Works Report

Updated assessment of an avenue of trees along
Bunbury Street, between Hyde and Moreland Streets,
Footscray.

Wednesday 4th May 2022

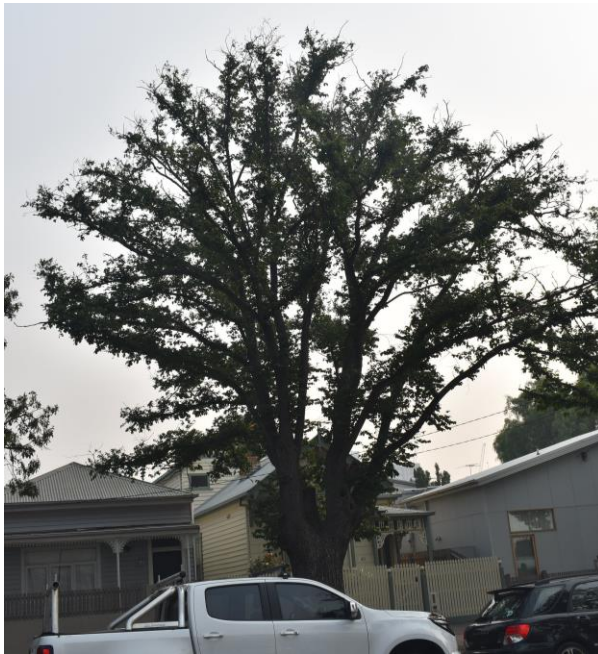
Figure 3: Large over-mature English Elm (Tree 12) in 'Poor' health

- 15 trees (Trees 10, 12, 14, 17, 22, 27-31, 36, 39, 40, 42 and 47) have been recommended for 'High' priority removal and replacement.
- Two trees (Trees 16 and 23) have been recommended for 'Moderate' priority removal.
- Following removal, new trees should be planted using advanced stock.

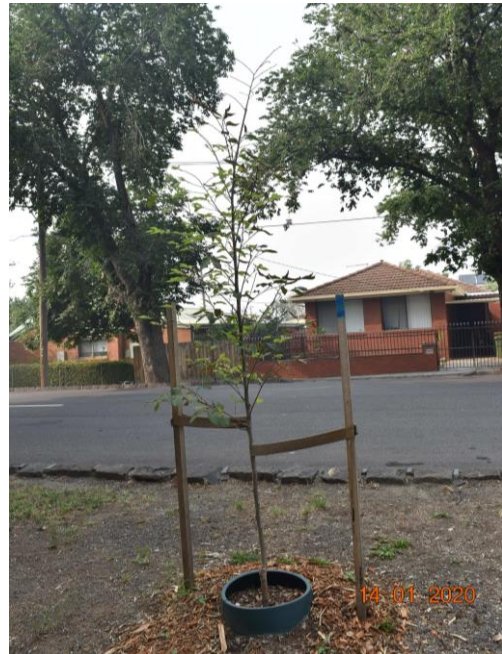
Figure 4: New planting in 'Poor' health requiring irrigation

13 young *Ulmus procera* have been planted throughout the avenue, increasing the overall ULEs of the assessed trees (Figure 19). However, many of these have declined since the previous assessment 2 years ago and irrigation is required to ensure their ongoing health and longevity.

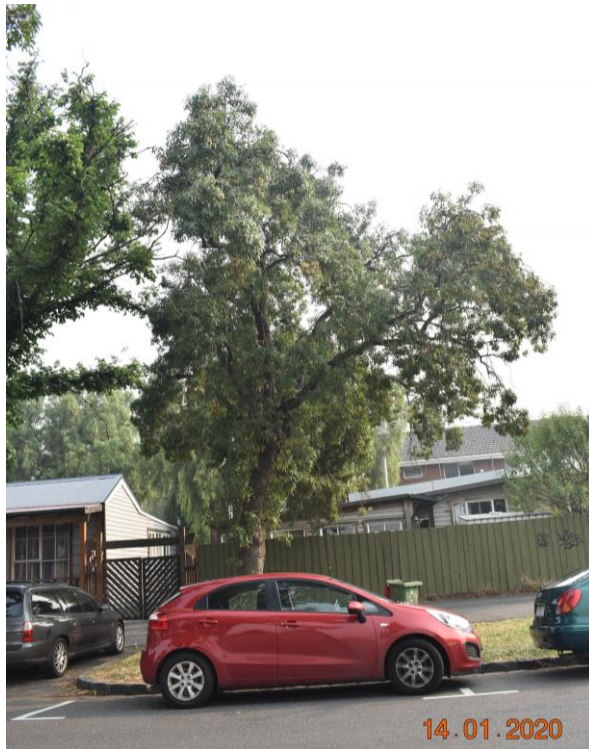
Figure 5: Tree 16 in 2020

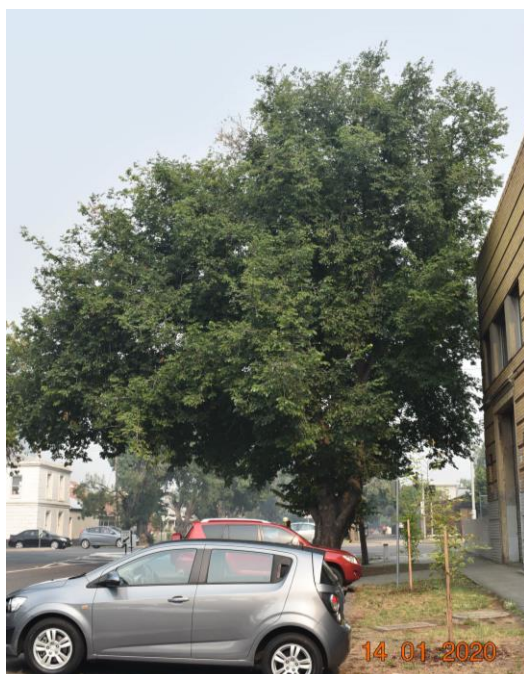
Figure 7: Tree 22 in 2020

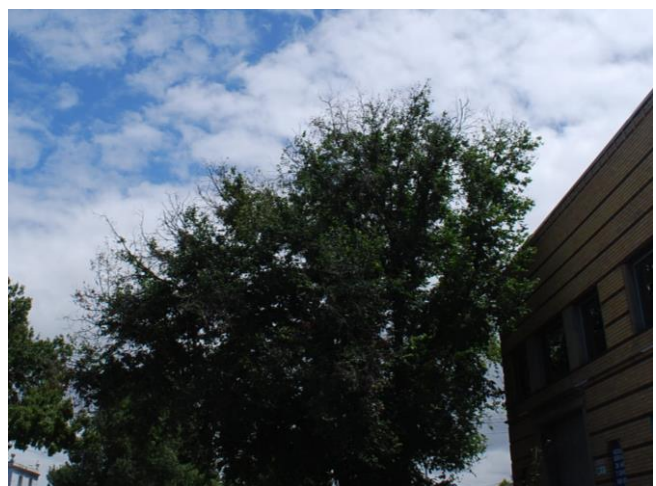
Figure 8: Tree 22 in 2022. Dieback of tips is evident

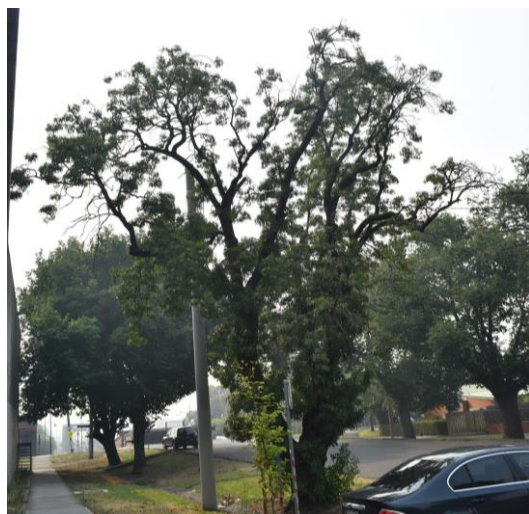
Figure 9: Tree 23 in 2020

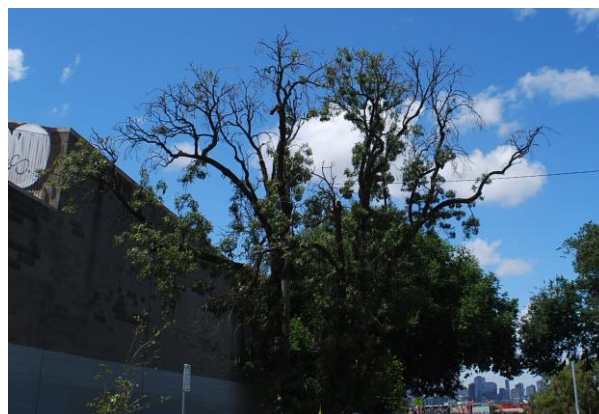
Figure 10: Tree 23 in 2022. Major dieback of branches

Tree Number: 23**Botanical Name:** *Fraxinus angustifolia subsp. angustifolia***Common Name:** Desert Ash**Assessment Level:** Level 2**Height & Width (m):** 10 x 8**DBH (cm):** 84**Health:** Poor**Structure:** Fair**ULE:** Less than 5 years**Maturity:** Mature**Recommended Works:** Removal**Priority:** Moderate**Failure Potential:** 3. Moderate**Failure Size:** 3. 101-250mm**Target Occupancy:** 2. Pedestrians, 8-72/hr**Risk of Harm** **1 in 50,000****Risk Category:** Moderate**Comments:** Major dieback and deadwood

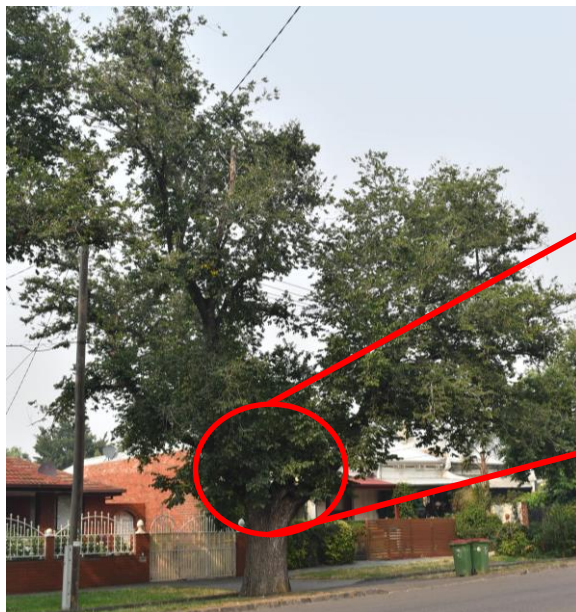
Multiple pruning events of a tree along with age can also open the tree to infection and extensive decay (Figure 14 and Figure 15, overleaf) as well as hazardous epicormic growth which is usually a response to stress (i.e. major loss of canopy, drought, fire etc). Epicormic growth provides rapid energy to a tree and in the short-term it benefits most trees (Shigo 1991). It is the long-term effects of epicormic growth that cause concern. Epicormic growth is produced from dormant buds that lie beneath the bark of a tree. This growth does not form part of the tree's natural structure and, once the resultant branches reach a large size, they are very prone to failure (Shigo 1991).

Figure 14: Tree 31 with evidence of a previous pruning event

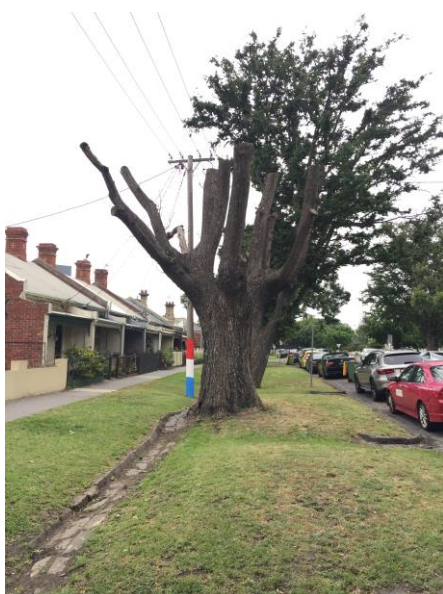
Figure 18: Tree 39 assessed as having a ULE of 0 years

Over-mature Elms within the avenue have low ULEs. ULEs have been used as a guide for the removal and replacement for restoration of the avenue. Trees with ULEs of 0 or 1-5 years have been recommended for removal and replanting.

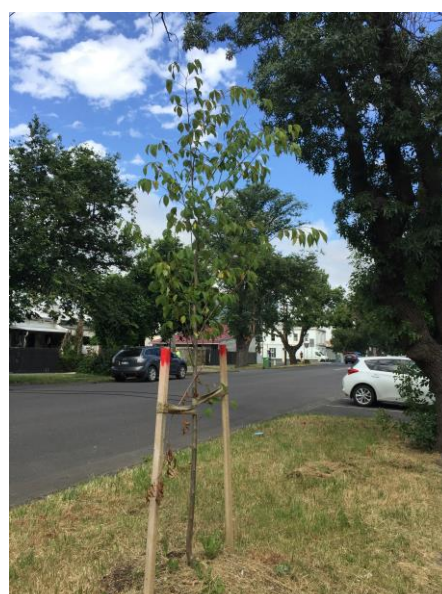
Figure 19: Tree 24, newly planted *Ulmus procera* with a ULE 40+ years

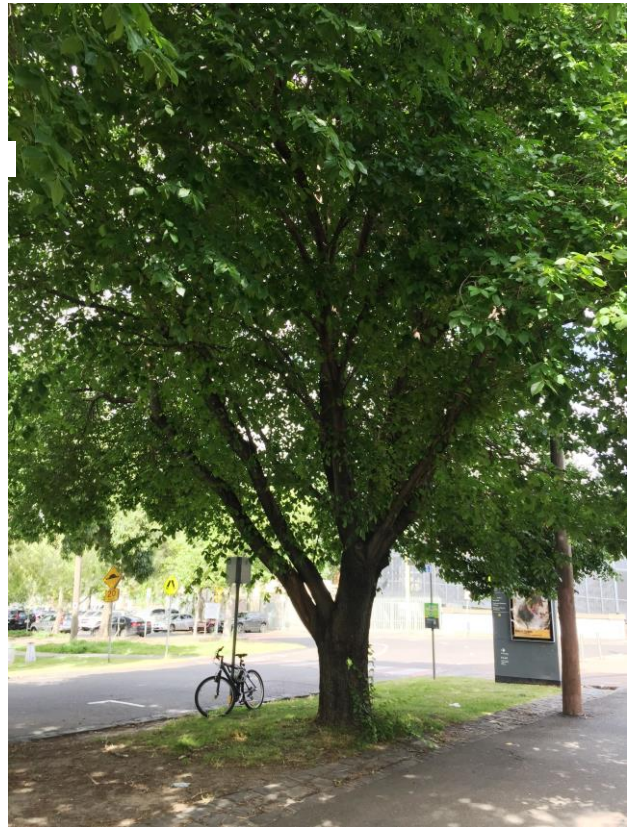
Tree Number:	1
Botanical Name:	<i>Ulmus procera</i>
Common Name:	English Elm
Assessment Level:	Level 3 - Tomograph
Height & Width (m):	11 x 13
DBH (cm):	61
Health:	Good
Structure:	Fair
ULE:	40+ years
Maturity:	Mature
Recommended Works:	Canopy lift, 10% risk reduction pruning, property clearance (light)
Priority:	Moderate
Failure Potential:	4. Low
Failure Size:	3. 101-250mm
Target Occupancy:	2. Pedestrians, 8-72/hr
Risk of Harm	1 in 500,000
Risk Category:	Moderate
Comments:	Tomograph results show excellent condition at the test site

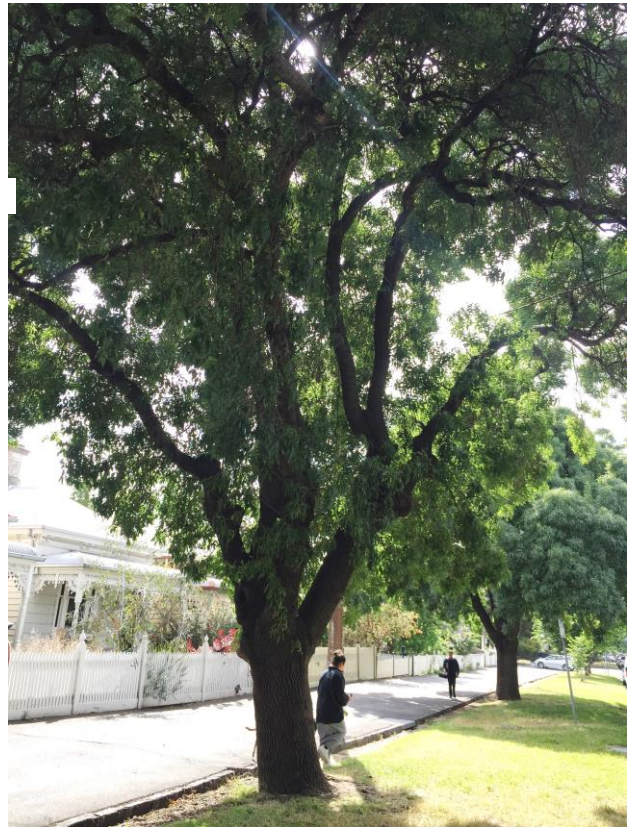
Comments: Tomograph results show very good condition at the test site

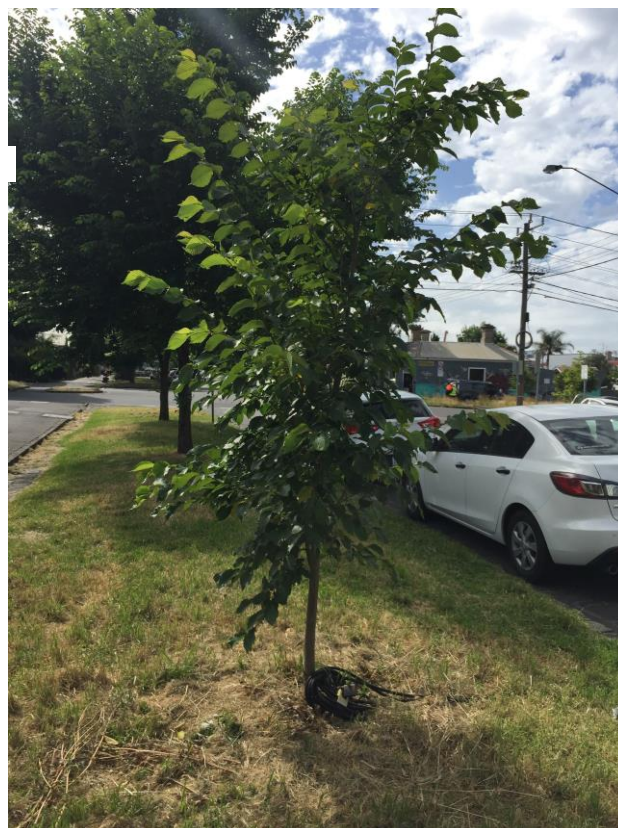
Tree Number: 6
Botanical Name: *Ulmus procera*
Common Name: English Elm
Assessment Level: Level 2
Height & Width (m): 2 x 1
DBH (cm): 2
Health: Good
Structure: Good
ULE: 40+ years
Maturity: Young
Recommended Works: No works
Priority: None
Failure Potential: 5. Very Low
Failure Size: 4. 26-100mm
Target Occupancy: 2. Pedestrians, 8-72/hr
Risk of Harm **1 in 50,000,000**
Risk Category: Very low
Comments:

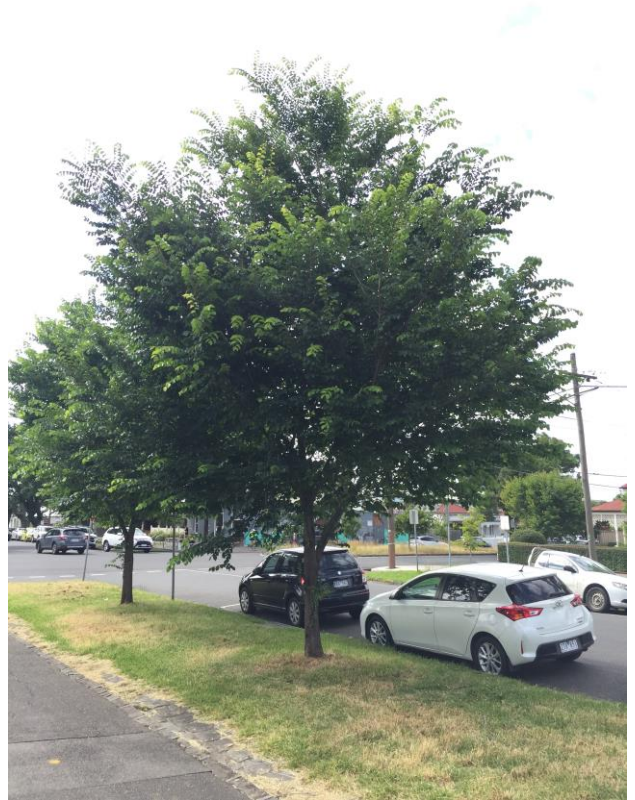
Botanical Name: *Ulmus procera*
Common Name: English Elm
Assessment Level: Level 2
Height & Width (m): 6 x 4
DBH (cm): 20
Health: Good
Structure: Fair
ULE: 20 to 40 years
Maturity: Semi mature
Recommended Works: No works
Priority: None
Failure Potential: 4. Low
Failure Size: 4. 26-100mm
Target Occupancy: 2. Pedestrians, 8-72/hr
Risk of Harm **1 in 5,000,000**
Risk Category: Low
Comments: Borers, inclusion in main stem

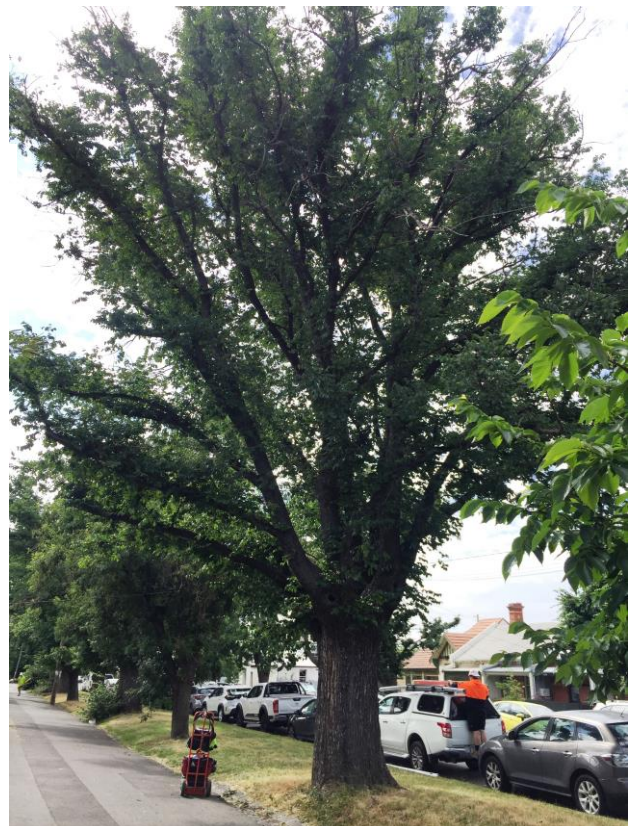
**Tree Number: 10****Botanical Name:** *Ulmus procera***Common Name:** English Elm**Assessment Level:** Level 3 - Aerial Inspection, Tomograph**Height & Width (m):** 12 x 10**DBH (cm):** 103**Health:** Poor**Structure:** Fair**ULE:** 0 years**Maturity:** Mature**Recommended Works:** Removal**Priority:** High**Failure Potential:** 2. High**Failure Size:** 3. 101-250mm**Target Occupancy:** 2. Pedestrians, 8-72/hr**Risk of Harm** **1 in 5,000****Risk Category:** High**Comments:** Tomograph results show a compromised trunk with heavy decay at the test site

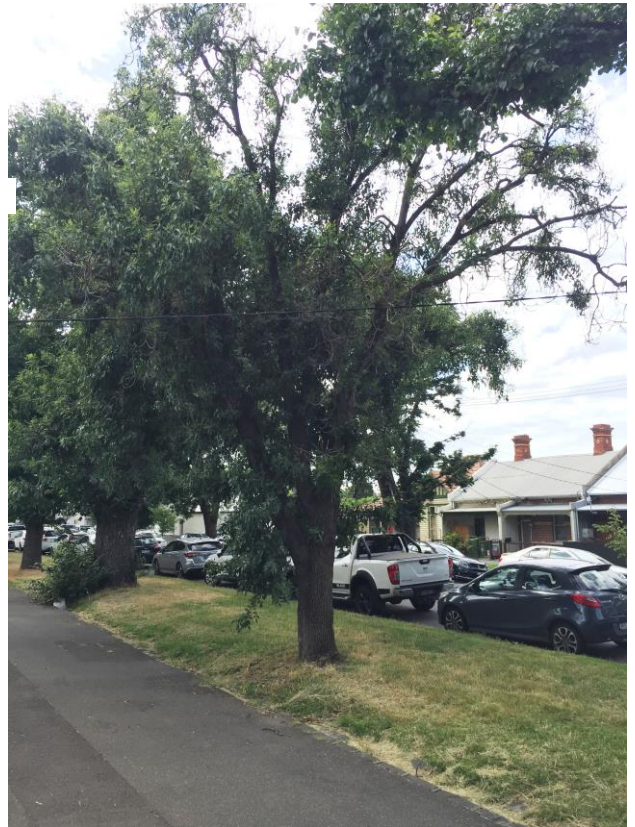
Comments: Possum damage

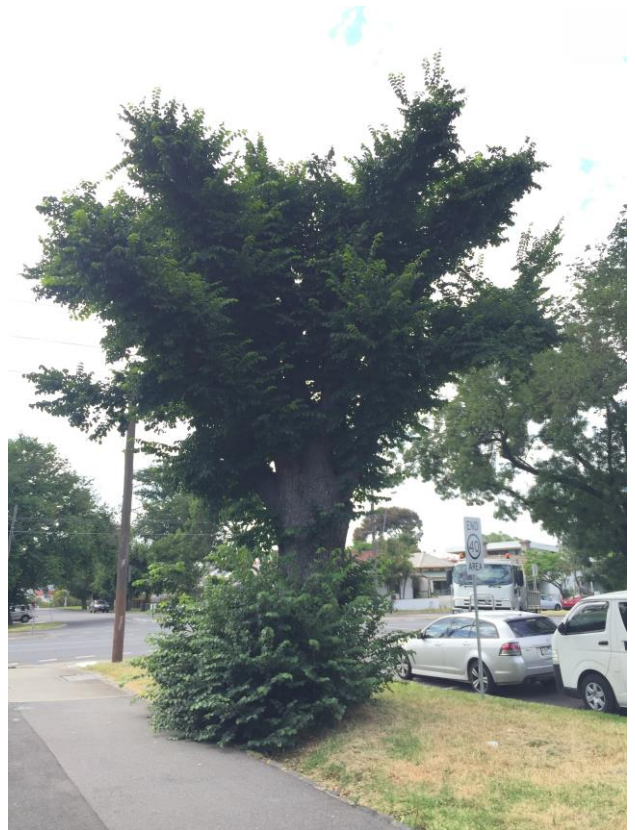
Tree Number: 17**Botanical Name:** *Ulmus procera***Common Name:** English Elm**Assessment Level:** Level 2**Height & Width (m):** 9 x 6**DBH (cm):** 115**Health:** Poor**Structure:** Poor**ULE:** 5 to 10 years**Maturity:** Mature**Recommended Works:** Removal**Priority:** High**Failure Potential:** 4. Low**Failure Size:** 4. 26-100mm**Target Occupancy:** 2. Pedestrians, 8-72/hr**Risk of Harm** **1 in 5,000,000****Risk Category:** Low**Comments:** Previous large failures, lopped at trunk, epicormic growth. ULE extended due to being lopped and risk reduced

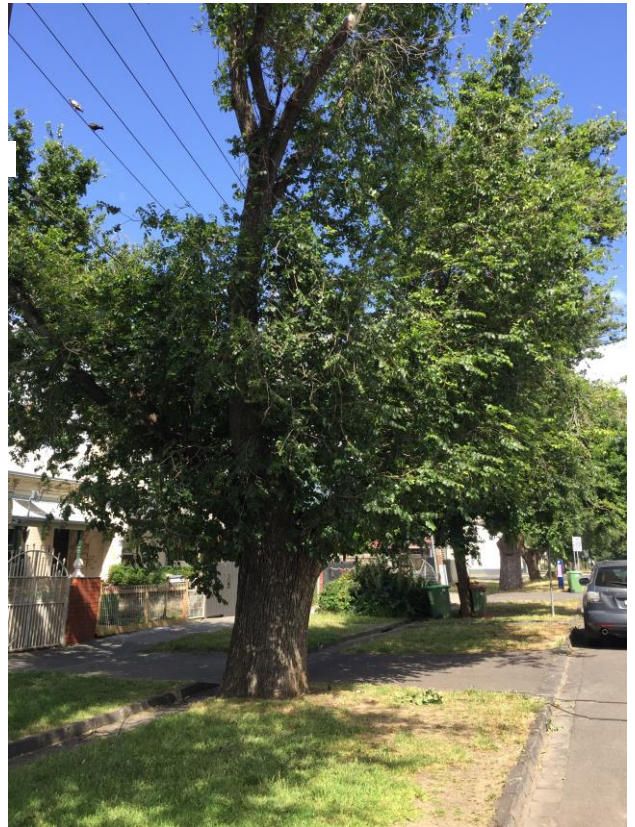
Tree Number: 31**Botanical Name:** *Ulmus procera***Common Name:** English Elm**Assessment Level:** Level 3 - Aerial Inspection**Height & Width (m):** 10 x 12**DBH (cm):** 100**Health:** Fair**Structure:** Poor**ULE:** 0 years**Maturity:** Mature**Recommended Works:** Removal**Priority:** High**Failure Potential:** 2. High**Failure Size:** 2. 251-450mm**Target Occupancy:** 2. Pedestrians, 8-72/hr**Risk of Harm** **1 in 1,000****Risk Category:** Very high

Comments: Column of decay in trunk, large cavity between multiple stem unions at top of trunk, Decay extends into nearly all first order stems

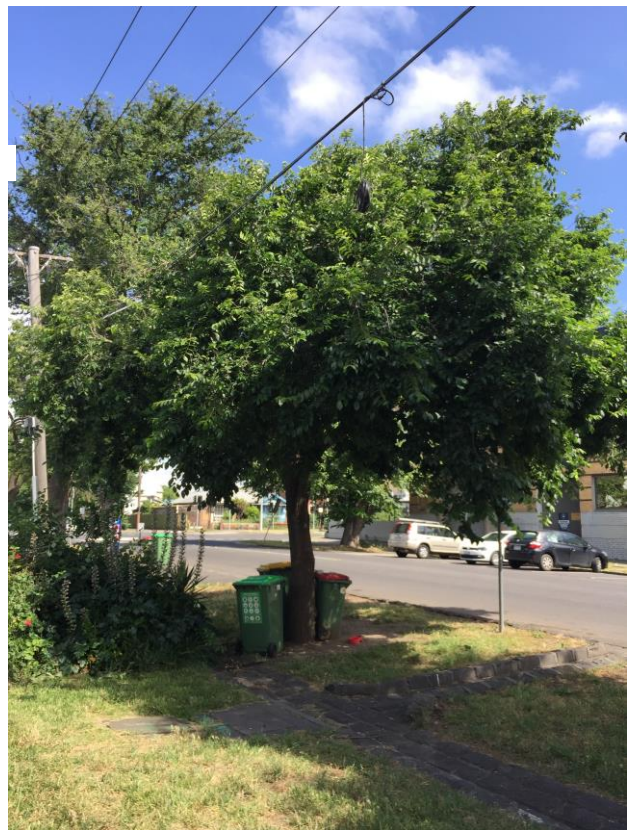
**Tree Number:** 32**Botanical Name:** *Ulmus procera***Common Name:** English Elm**Assessment Level:** Level 2**Height & Width (m):** 6 x 5**DBH (cm):** 32**Health:** Good**Structure:** Good**ULE:** 40+ years**Maturity:** Semi mature**Recommended Works:** No works**Priority:** None**Failure Potential:** 4. Low**Failure Size:** 4. 26-100mm**Target Occupancy:** 2. Pedestrians, 8-72/hr**Risk of Harm** **1 in 5,000,000****Risk Category:** Low**Comments:**

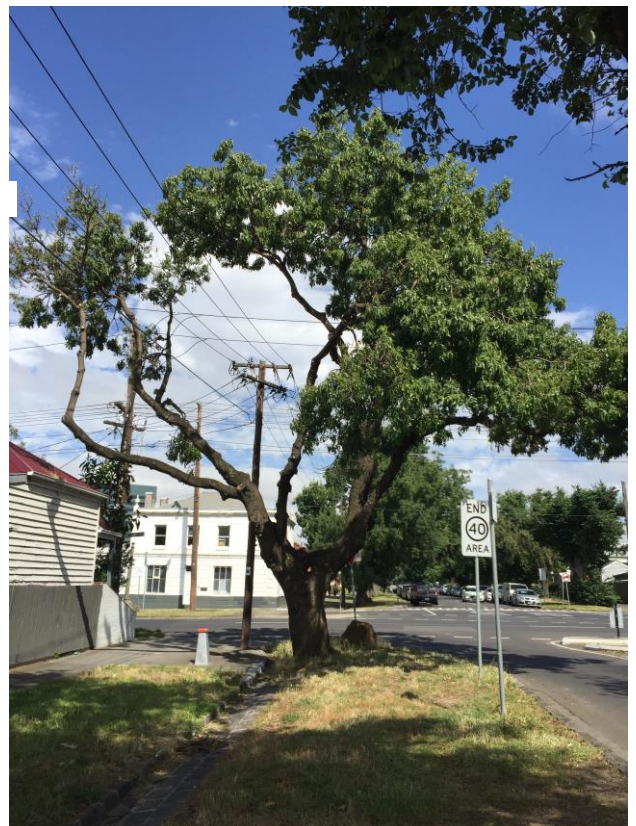
Tree Number: 34
Botanical Name: *Fraxinus angustifolia subsp. angustifolia*
Common Name: Desert Ash
Assessment Level: Level 3 - Tomograph
Height & Width (m): 11 x 12
DBH (cm): 80
Health: Fair
Structure: Fair
ULE: 10 to 20 years
Maturity: Mature
Recommended Works: No works
Priority: None
Failure Potential: 3. Moderate
Failure Size: 3. 101-250mm
Target Occupancy: 2. Pedestrians, 8-72/hr
Risk of Harm **1 in 50,000**
Risk Category: Moderate
Comments: Tomograph results show excellent condition at the test site

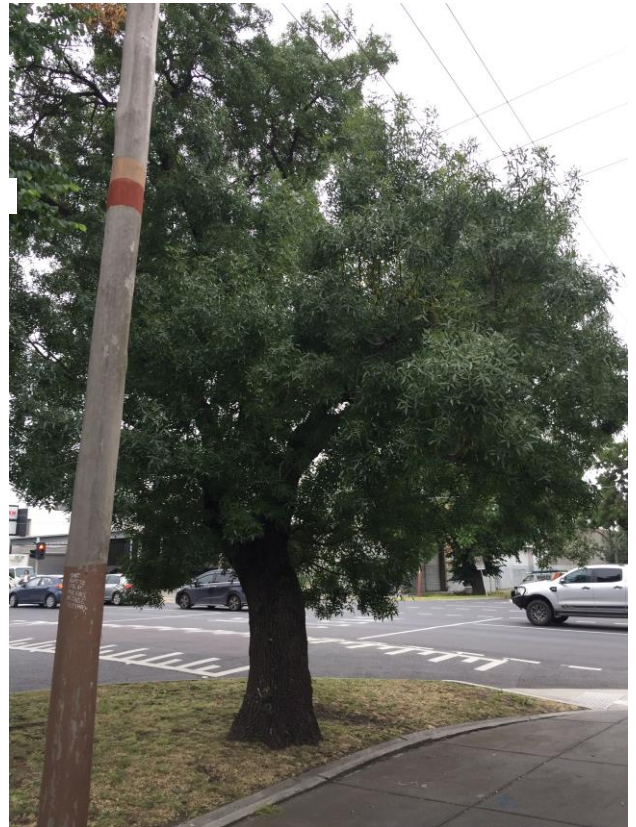
Tree Number: 35

Risk Category: Moderate

Comments: Tomograph results show excellent condition at the test site

Recommended Works: No works

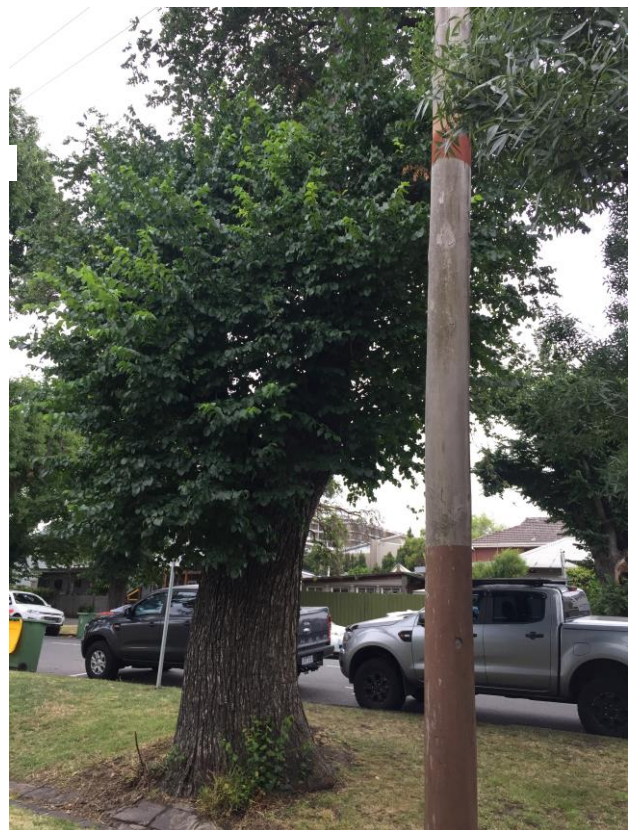
Tree Number: 36

Failure Potential: 2. High

Failure Size: 2. 251-450mm

Risk Category: Very high

Comments: Tomograph results show a compromised trunk with heavy decay at the test site.

Recommended Works: Removal

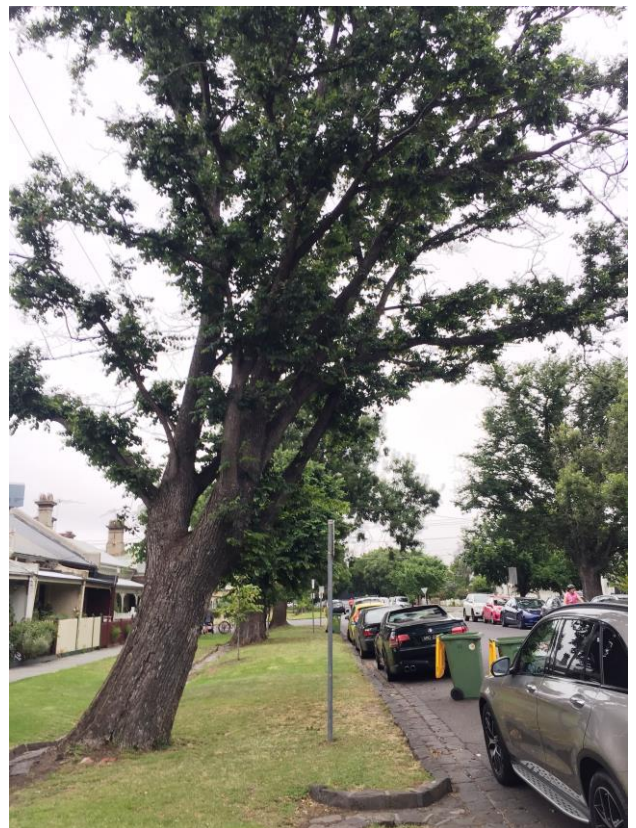
Tree Number:	40
Botanical Name:	<i>Ulmus procera</i>
Common Name:	English Elm
Assessment Level:	Level 2
Height & Width (m):	12 x 7
DBH (cm):	100
Health:	Poor
Structure:	Poor
ULE:	0 years
Maturity:	Mature
Recommended Works:	Removal
Priority:	High
Failure Potential:	2. High
Failure Size:	2. 251-450mm
Target Occupancy:	2. Pedestrians, 8-72/hr
Risk of Harm	1 in 1,000
Risk Category:	Very high
Comments:	Declining in health and with significant lean. Previous root plate movement.

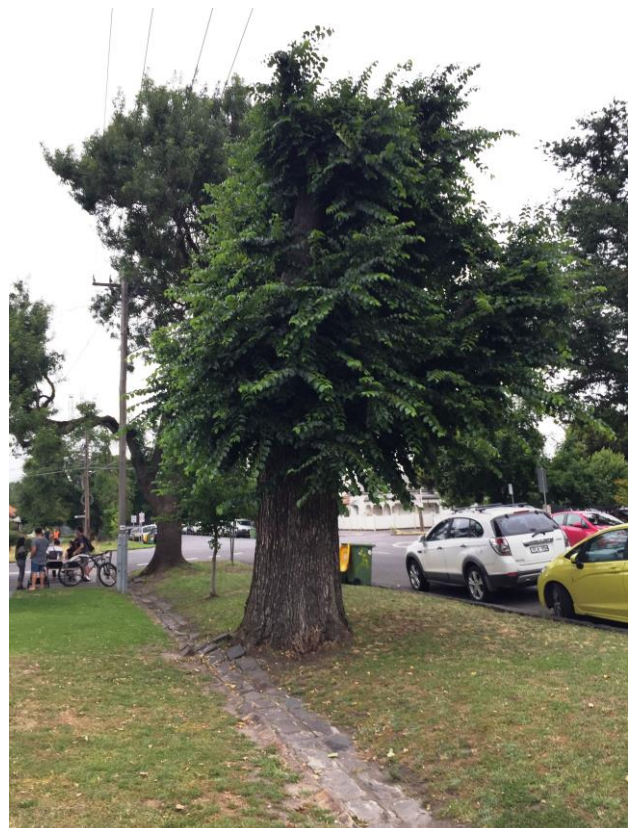
**Tree Number:** 42**Botanical Name:** *Ulmus procera***Common Name:** English Elm**Assessment Level:** Level 2**Height & Width (m):** 7 x 4**DBH (cm):** 116**Health:** Poor**Structure:** Poor**ULE:** 0 years**Maturity:** Mature**Recommended Works:** Removal**Priority:** High**Failure Potential:** 4. Low**Failure Size:** 4. 26-100mm**Target Occupancy:** 2. Pedestrians, 8-72/hr**Risk of Harm** 1 in 5,000,000**Risk Category:** Low**Comments:** Lopped

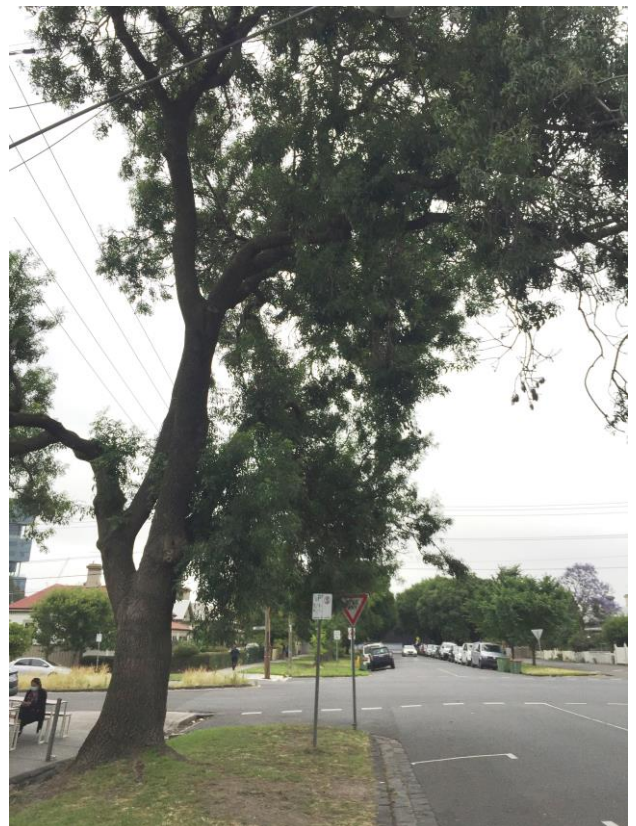
**Tree Number:** 44**Botanical Name:** *Fraxinus angustifolia subsp. angustifolia***Common Name:** Desert Ash**Assessment Level:** Level 2**Height & Width (m):** 13 x 15**DBH (cm):** 85**Health:** Good**Structure:** Fair**ULE:** 20 to 40 years**Maturity:** Mature**Recommended Works:** Deadwood removal, Canopy lift**Priority:** Moderate**Failure Potential:** 3. Moderate**Failure Size:** 3. 101-250mm**Target Occupancy:** 2. Human Occupancy, 2.5hrs/day to 15**Risk of Harm** **1 in 50,000****Risk Category:** Moderate**Comments:** Lift over property

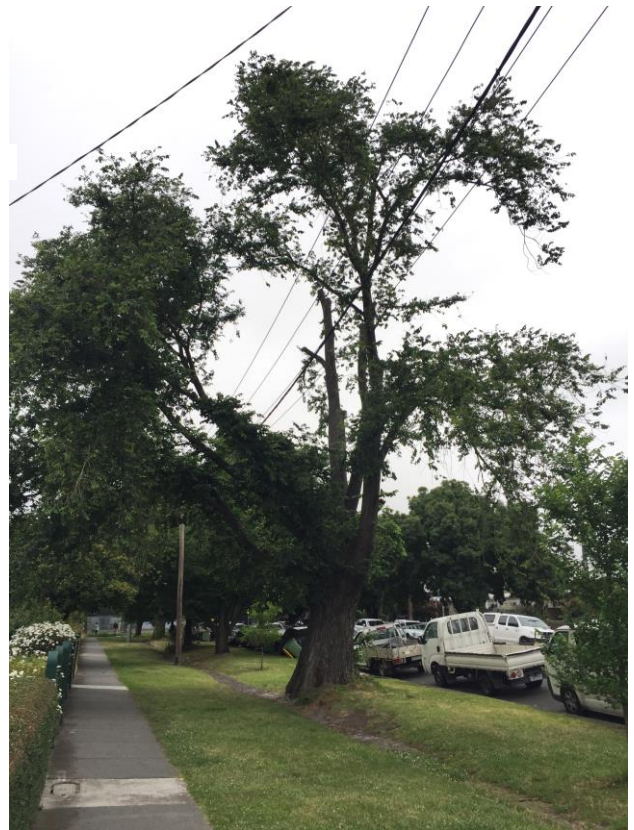
Tree Number: 47**Botanical Name:** *Ulmus procera***Common Name:** English Elm**Assessment Level:** Level 3 - Aerial Inspection**Height & Width (m):** 12 x 14**DBH (cm):** 126**Health:** Fair**Structure:** Poor**ULE:** 0 years**Maturity:** Mature**Recommended Works:** Removal**Priority:** High**Failure Potential:** 2. High**Failure Size:** 3. 101-250mm**Target Occupancy:** 2. Pedestrians, 8-72/hr**Risk of Harm** **1 in 5,000****Risk Category:** High**Comments:** Lost large limb recently, has been lopped on one side

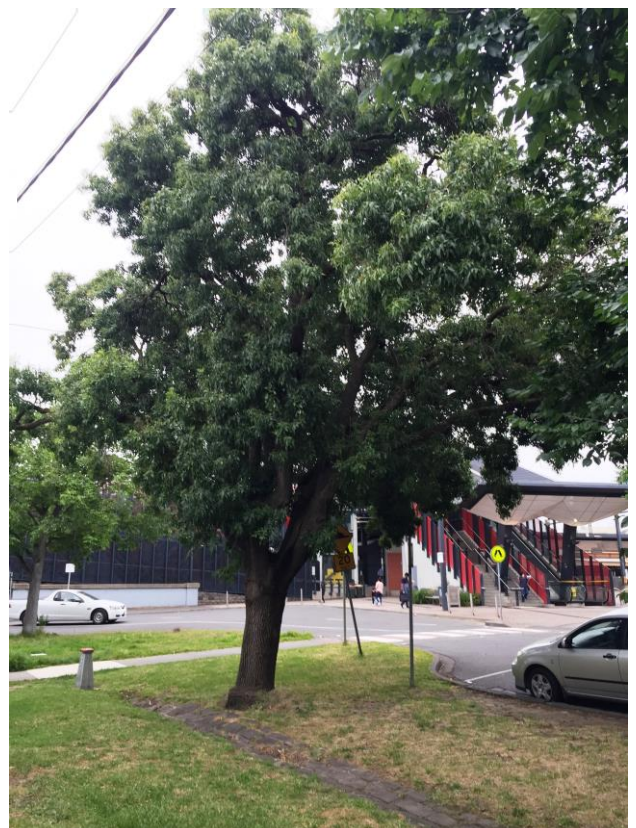
**Tree Number:** 54**Botanical Name:** *Fraxinus angustifolia subsp. angustifolia***Common Name:** Desert Ash**Assessment Level:** Level 2**Height & Width (m):** 12 x 10**DBH (cm):** 60**Health:** Good**Structure:** Good**ULE:** 20 to 40 years**Maturity:** Mature**Recommended Works:** 15-20% risk reduction pruning**Priority:** Moderate**Failure Potential:** 3. Moderate**Failure Size:** 3. 101-250mm**Target Occupancy:** 2. Pedestrians, 8-72/hr**Risk of Harm** **1 in 50,000****Risk Category:** Moderate**Comments:** Reduce compromised branch over parked cars
